MURALT WALLS: VIANE AND SCHELPHOEK, NETHERLANDS

GPR Investigation of Voiding below the Muralt
Walls
for
KOAC NPC

Project Number 3067

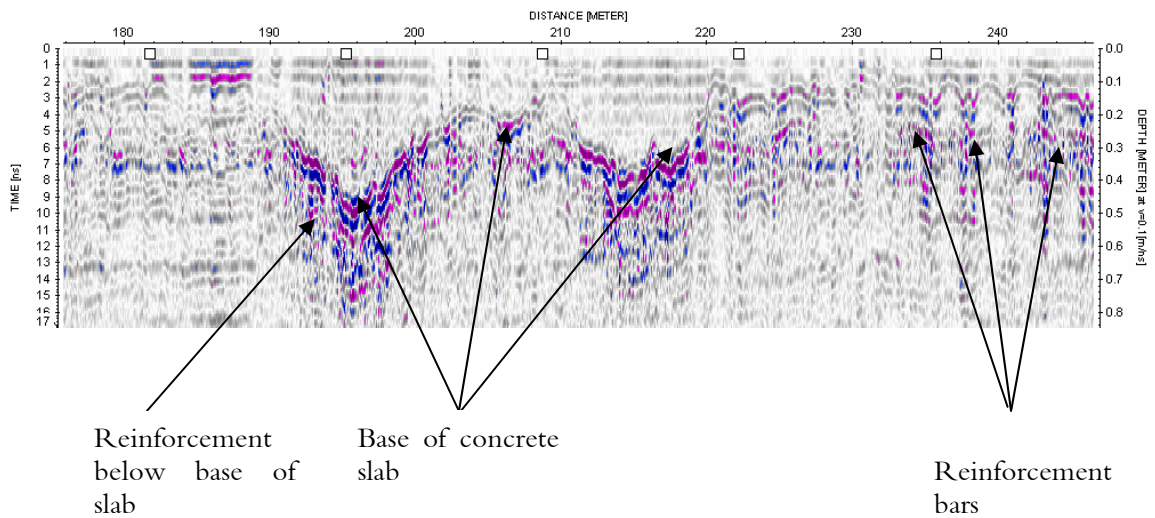
Figure 2: Longitudinal Profile (0.5m) at Schelphoek West over Construction Changes between Dijkpaal 55+c.175m and c.245m, 900MHz antenna

The drawing supplied by the client shows three changes in construction along the length of the survey area. Due to heavy vegetation on site, only two of these construction changes were surveyed, and changes in data were identified over both. It is therefore likely that the remaining unsurveyed construction change will be of similar construction to those already surveyed (Appendix A Figure 2). Plate 6, Appendix C shows an example of the surveyed construction change at Dijkpaal 55 +c.1327 m which was also visible on the surface.

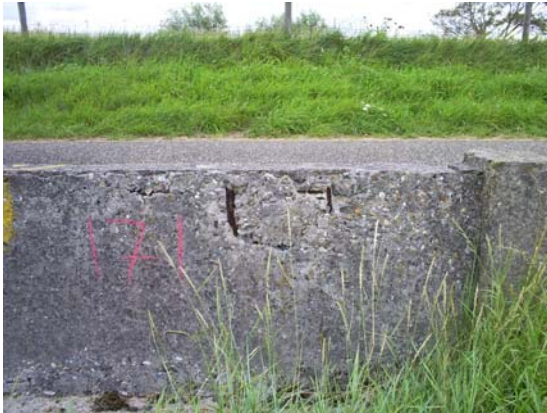
For the majority of the survey area the concrete appeared to be in good condition. In several places, particularly around Dijkpaal No. 329 there was cracking and/or spalling of the concrete and in some places reinforcement bars were exposed on the surface (Appendix C, Plates 1-4).

Plate 1: Viane, Dijkpaal No. 329 + c.63m:
Spalling evident in wall. Reinforcement bars visible.

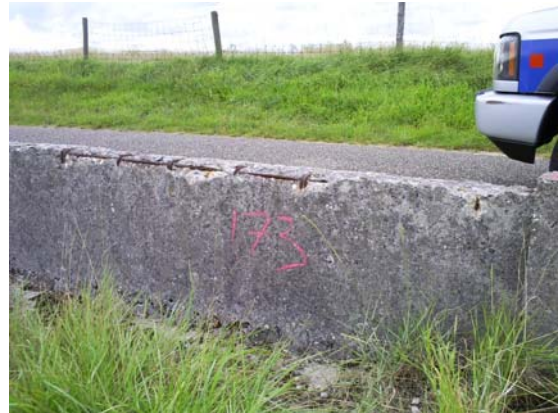
Plate 2: Viane, Dijkpaal No. 329 + c.55.5m:
Reinforcement bars visible along top of wall.

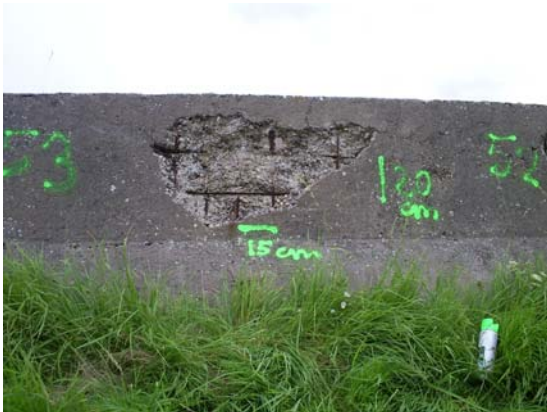
Plate 3: Viane, Dijkpaal No. 333 + c.54m:
Large area of spalling in wall. Reinforcement visible. Approximate dimensions marked on wall.

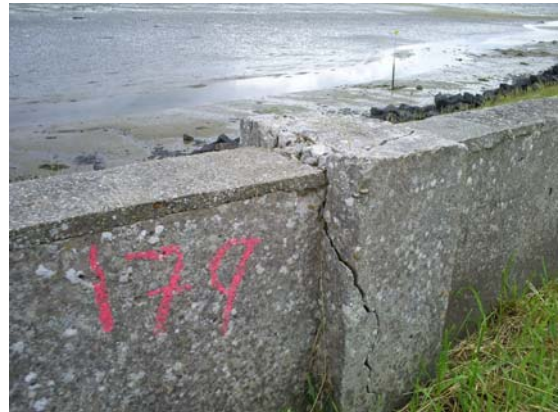
Plate 4: Viane, Dijkpaal No. 329 + 36.85m:
Cracking in post.

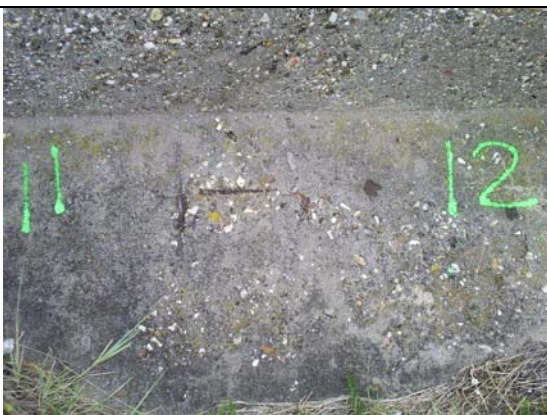
Large areas of concrete were obscured by vegetation which compromised the visual survey. However several of areas near the start of the survey (Dijkpaal 55) appeared to be in poorer condition (Appendix C, Plates 5-7).

Plate 5: Schelphoek, Dijkpaal No. 55 - c.67m:
Reinforcement visible on concrete slope.

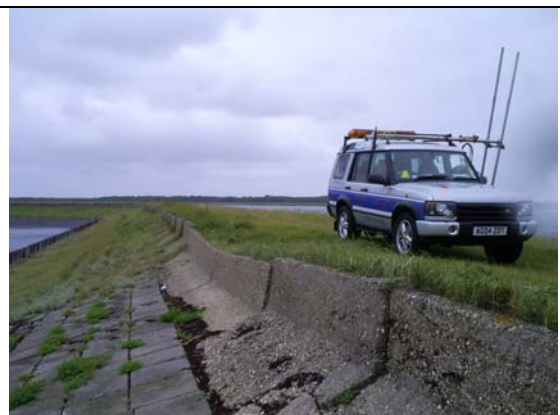
Plate 6: Schelphoek, Dijkpaal No. 55 +c.1327m
Change in construction at end of dyke (near survey limit) at Schelphoek West.

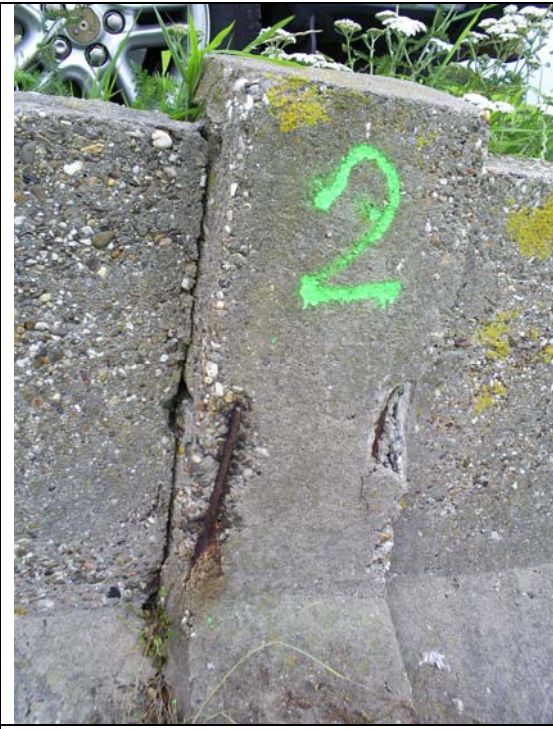
Plate 7: Schelphoek, Dijkpaal No. 55 – c.90m:
Reinforcement visible on post.

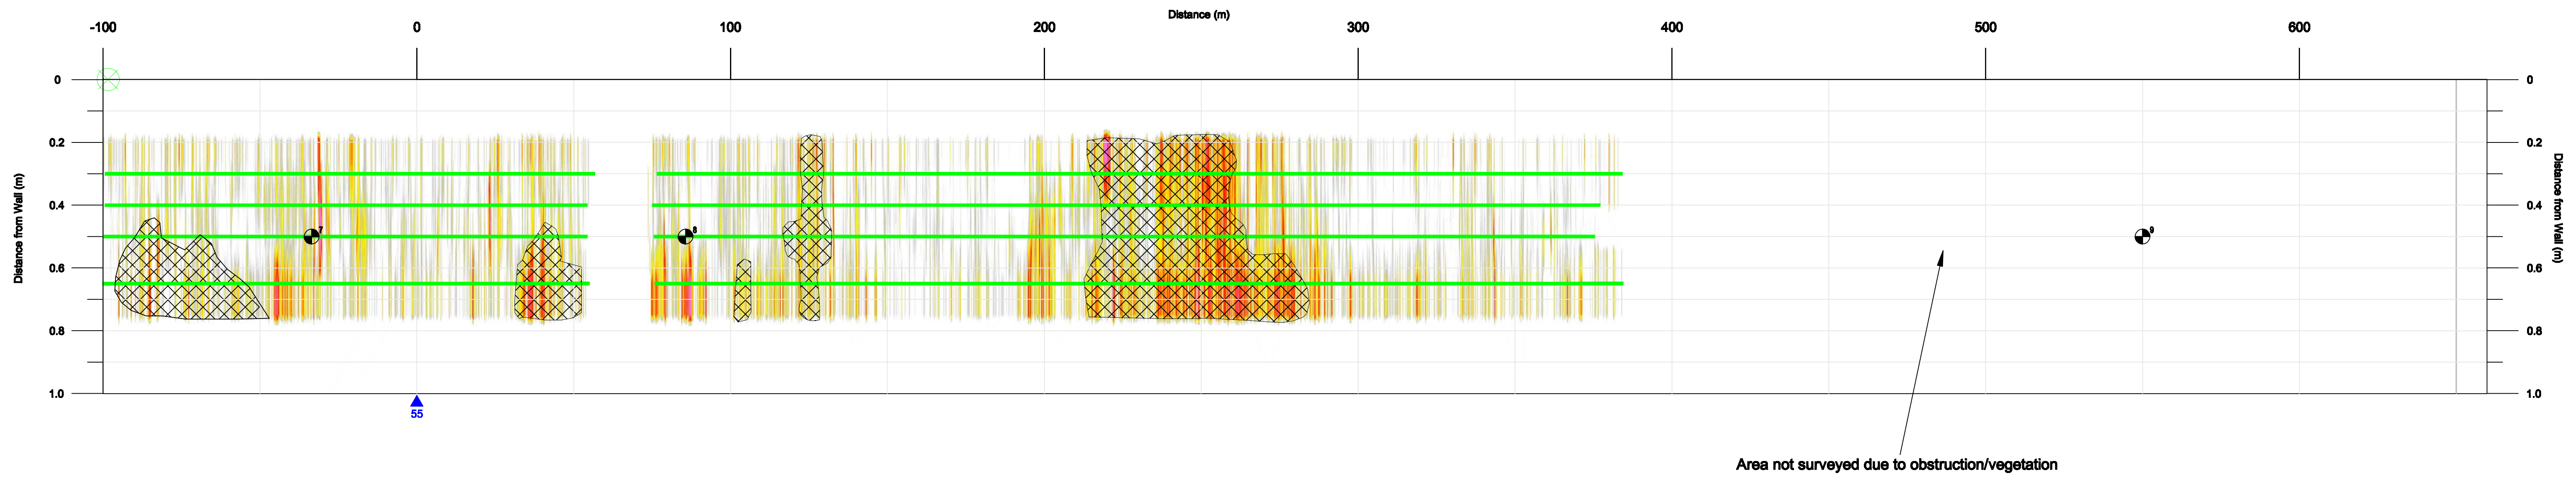
FIGURE 1: SCHELPHOEK WEST DIJKPAAL 55-100m TO DIJKPAAL 55+650m

Two areas of concern have been identified over the site.

Dijkpaal Start + m	Dijkpaal End + m	Approximate length of voiding (m)
55 - 50	55 - 15	35
55 + 75	55 + 95	20

It is likely that these higher amplitude areas are either indicative of changes in material below the slab (sand to clay) or areas of relatively poorer concrete condition, although areas of potential voiding are much more likely to exist within the areas of higher amplitude. It is in these areas that future intrusive investigations should be targeted.

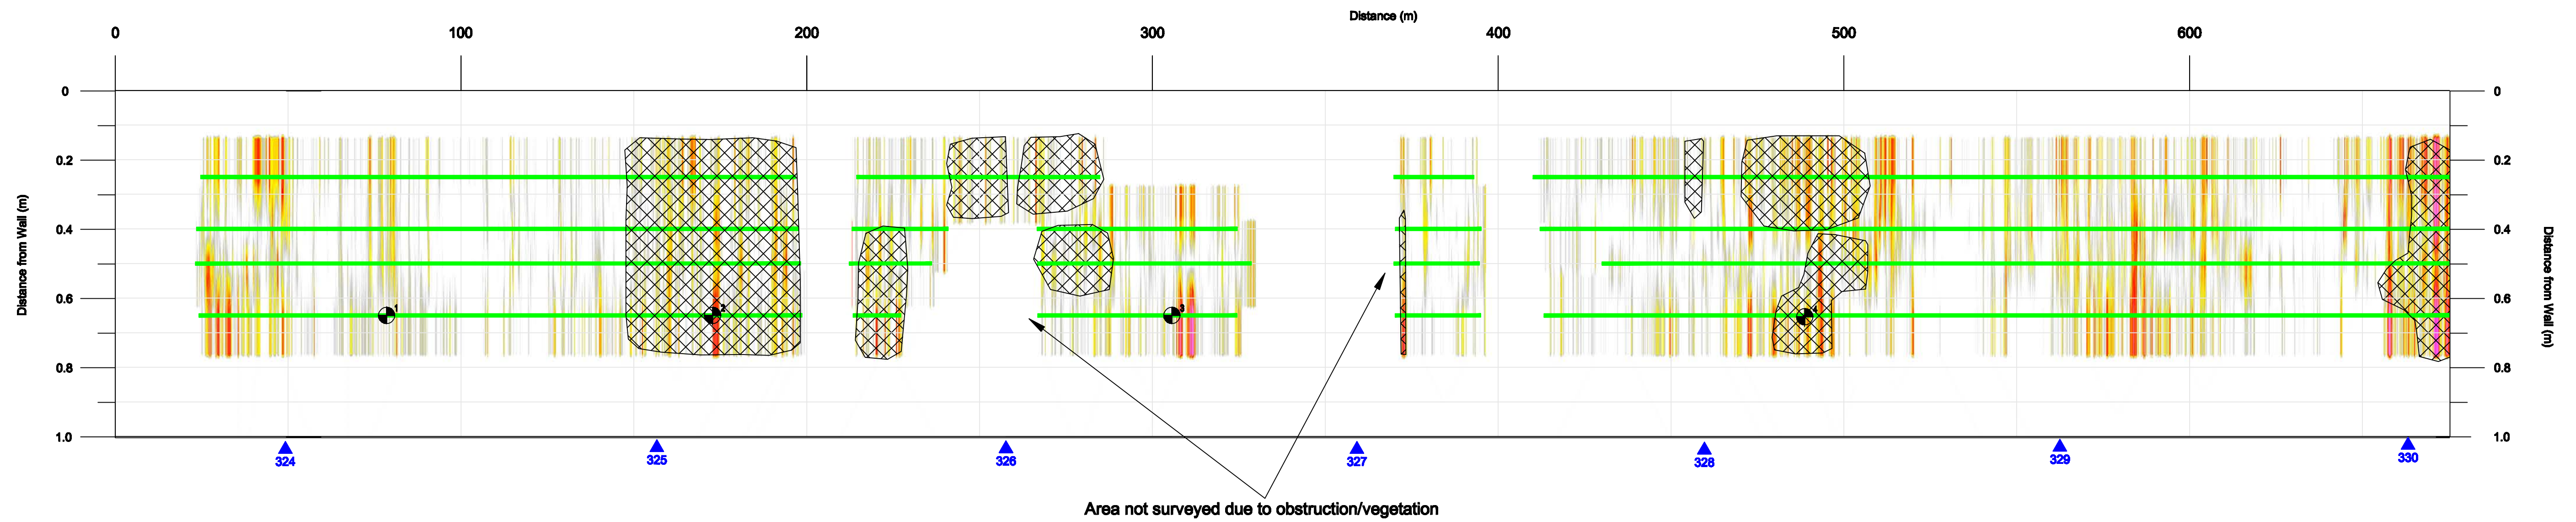
FIGURE 1: VIANE SECTION 1 DIJKPAAL 324 to DIJKPAAL 330

In general, section 1 appears to be in good condition with a number of smaller areas of potential voiding. Section 2 generally appears to show more evidence of voiding throughout.

Dijkpaal Start + m	Dijkpaal End + m	Approximate length of voiding (m)
324 - 30	324 + 0	30
329 + 0	329 + 50	5
331 - 55	331 + 0	55
336 - 50	336 - 22	28
337 +18	337 + 24	6
338 - 12	338 + 0	12
337 + 36.5	337 +45.5	9

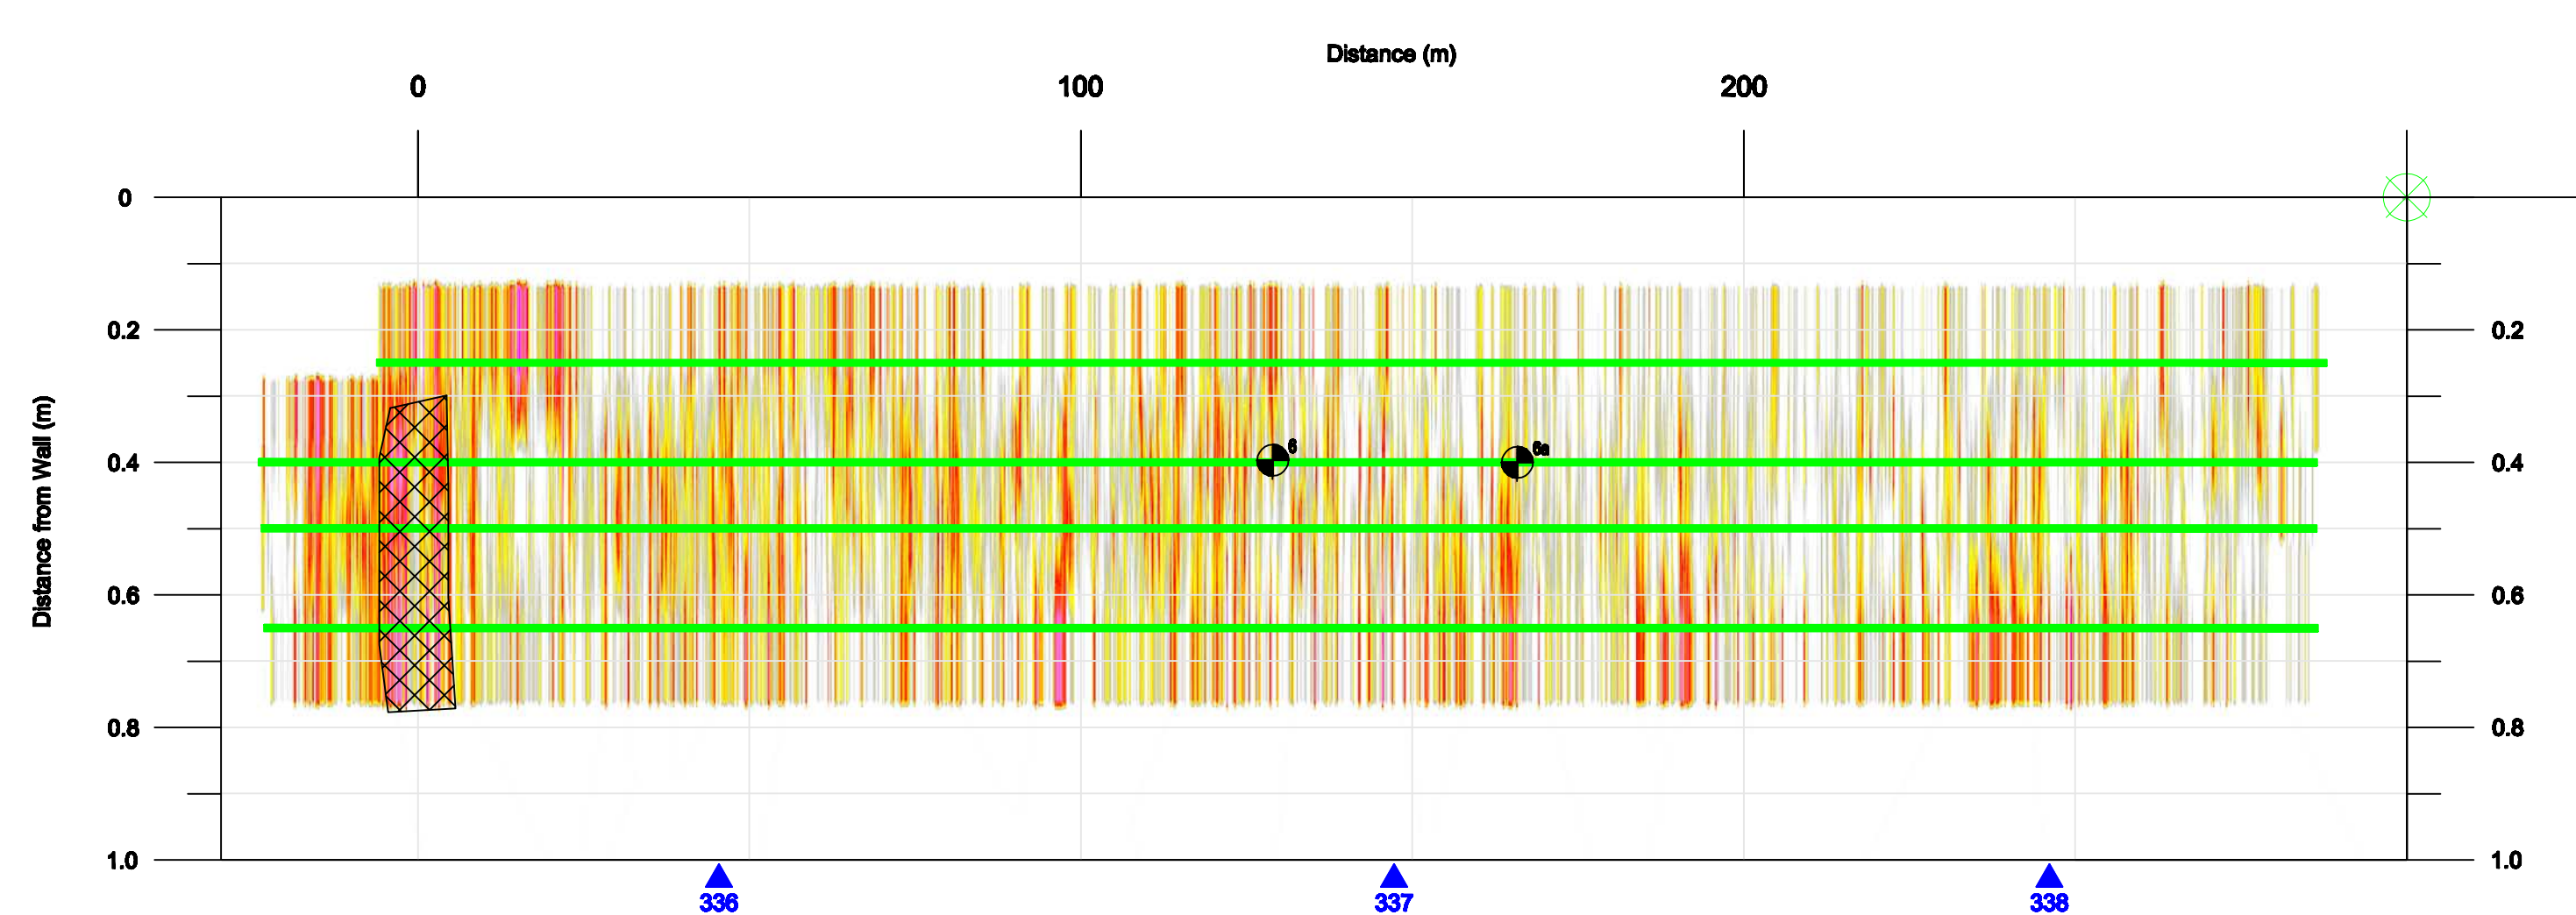
FIGURE 3: VIANE SECTION 2 DIJKPAAL 336 to DIJKPAAL 338

Six continuous areas of potential voiding were originally identified; three in section 2 and three in section 1. With the available calibration cores it is likely that the majority of high amplitude areas in section 1 are associated with either the presence of reinforcement, or clay rich ground conditions and not with the presence of voiding. The only core which exposed a void was extracted from section 2. In general it appears that this section (between dijkpaal 336 and dijkpaal 338) is in poorer condition than section 1.

The only location where voiding has been identified by coring is at 337 + 18.5 m, however similar areas of high amplitude response persist along much of section 2. Several large areas of concern exist along section 2 and it is recommended that any further intrusive testing should be concentrated in these areas. In addition to the areas in section 2, 3No. large areas of concern exist in section 1.
