Evaluation of Fish Injury and Mortality Associated
with scale models of the
Pentair Fairbanks Nijhuis Modified Bulb turbine
and the
Water2Energy Cross Flow turbine

**Evaluation of Fish Injury and Mortality Associated
with scale models of the Pentair Fairbanks Nijhuis
Modified Bulb turbine and the Water2Energy Cross
Flow turbine**

Report number: 20140961/rap02
Status: Final report
Date: 1-9-2015

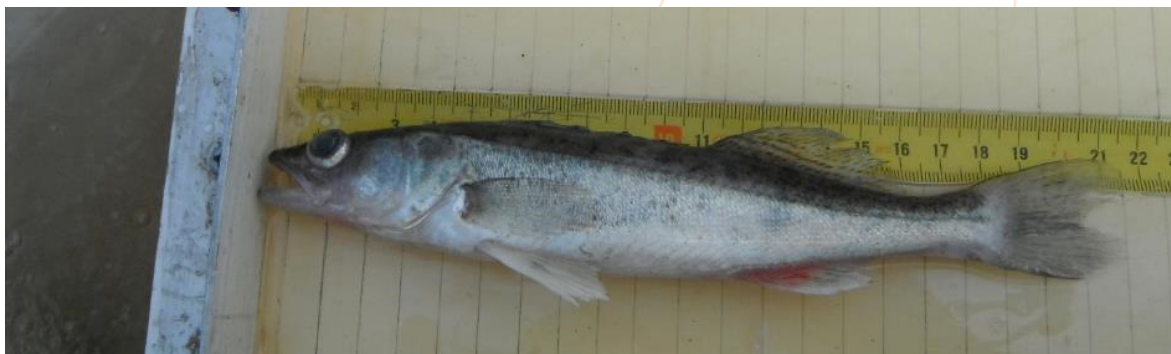
After performing test 1-1 it became obvious that there were several instant mortalities as a small number of fish was floating in the low water tank. In total 6 dead fish were counted with severe bruising/fracturing, damage to the eyes and haemorrhaging.

Figure 19. Dead pike perch, with severe bruising, damage to the eyes and haemorrhaging

In general all 6 fish show the same type of lethal damage, likely due to collision with turbine blades. Death was probably instant, due to severing the artery from the Bulbus arteriosus, causing heavy internal bleeding resulting in pale gills, rupturing of the swim bladder.

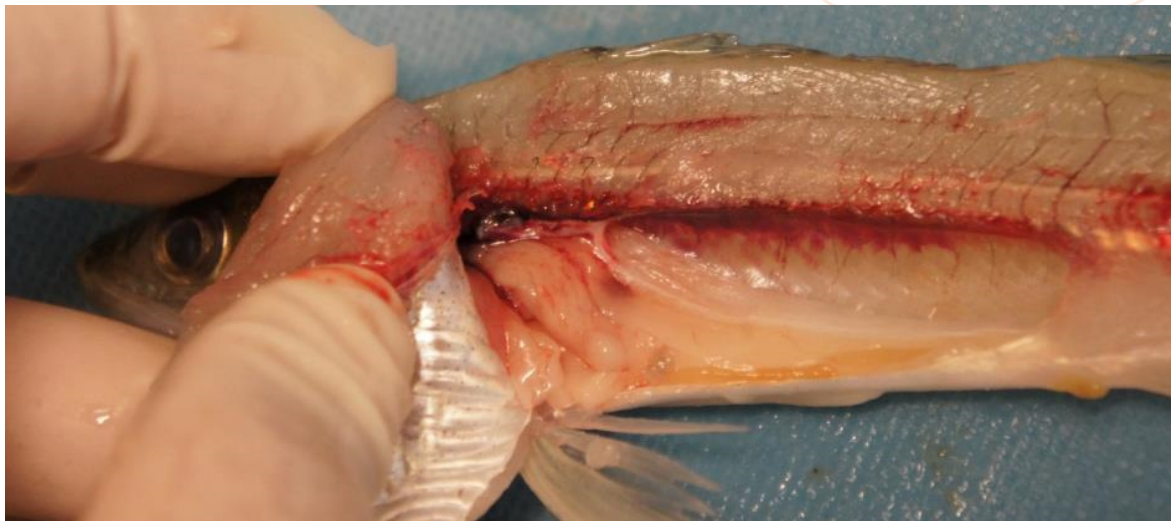
Figure 20. Pike perch with severe internal bleeding due to rupture of artery

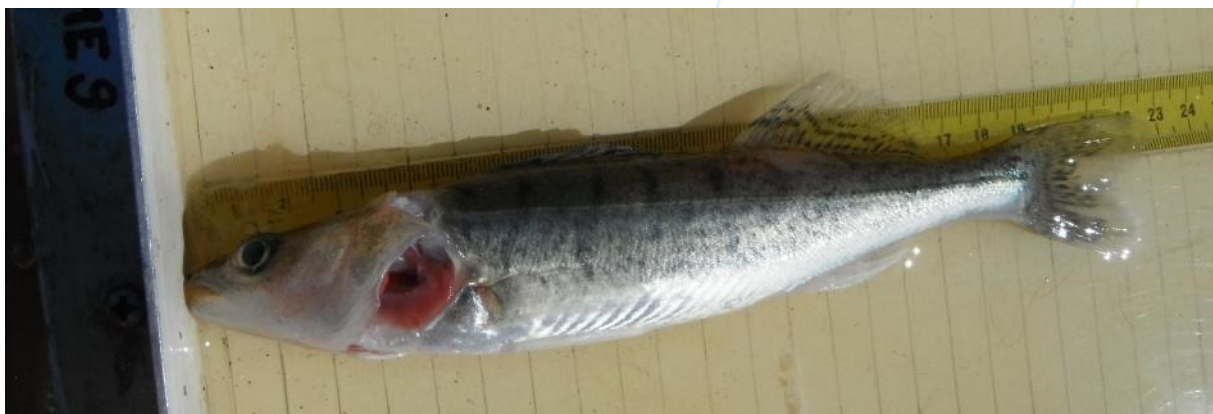
Test 1-1, with the cross flow turbine, led to 6 fatalities. One of these fish had a fractured spine just posterior of the head (figure 21). The other fatalities were also collision victims, suffering from severe bruising in the region of the head mainly, haemorrhaging (figure 22) and some damage to pectoral fins.

Three pike perch suffered some slight damage in the form of bruising near the head or in the dorsal area. Mortality after 48 hours was zero. Although no autopsy was performed, due to the nature of the damage and injuries, same causes of death are likely. Severe bodily trauma due to collision with moving parts of the turbine.

Figure 21. Pike perch with fractured spine just posterior of the head

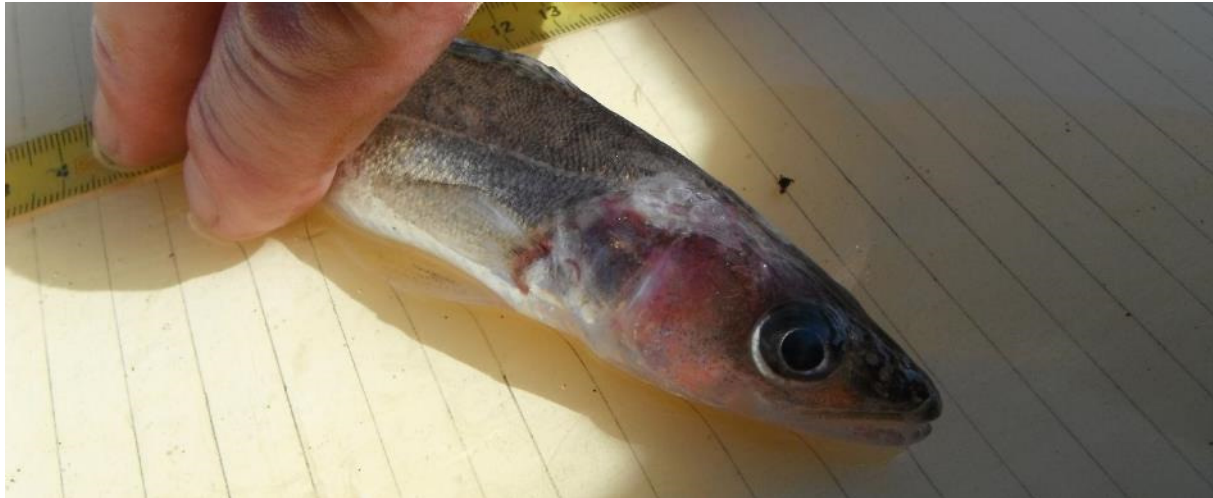
Figure 22. Severe bruising and haemorrhaging near head
