7 mei 2015

1210179-000-ZKS-0004

On the relationship between dike revetments and ecology: lessons learned for design and follow-up monitoring for asphalt covered locations

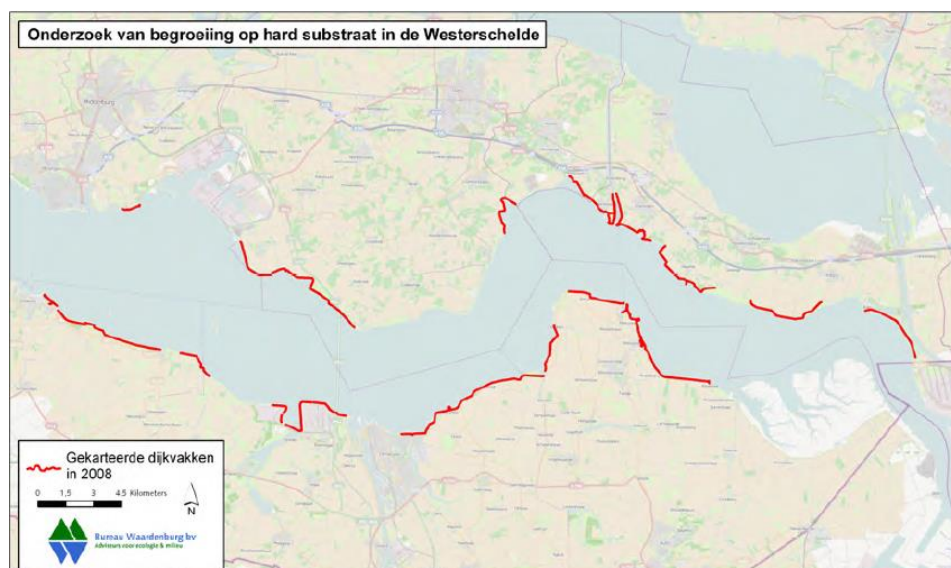
Figure 3.1 Monitored hard substrate along the Western Scheldt coastline in 1990 and 2008 (Meijer et al, 2011).

One of the larger inventories that have been performed is the inventory of the weeds along the dikes of the Western Scheldt in both 1990 and 2008 by Meijer et al (2011), Figure 3.1. This monitoring was based on the community typology work of Meijer & Van Beek (1988) and has qualified vegetation on different substrates in 1990 and 2008. Between 1990 and 2008 much of the patchy revetments on dikes have been replaced (Meijer et al. 2011). Performed inventories have made a link to the substrate on which the communities where found. Along with that, some comments are made on design which will be included in Table 4.1.

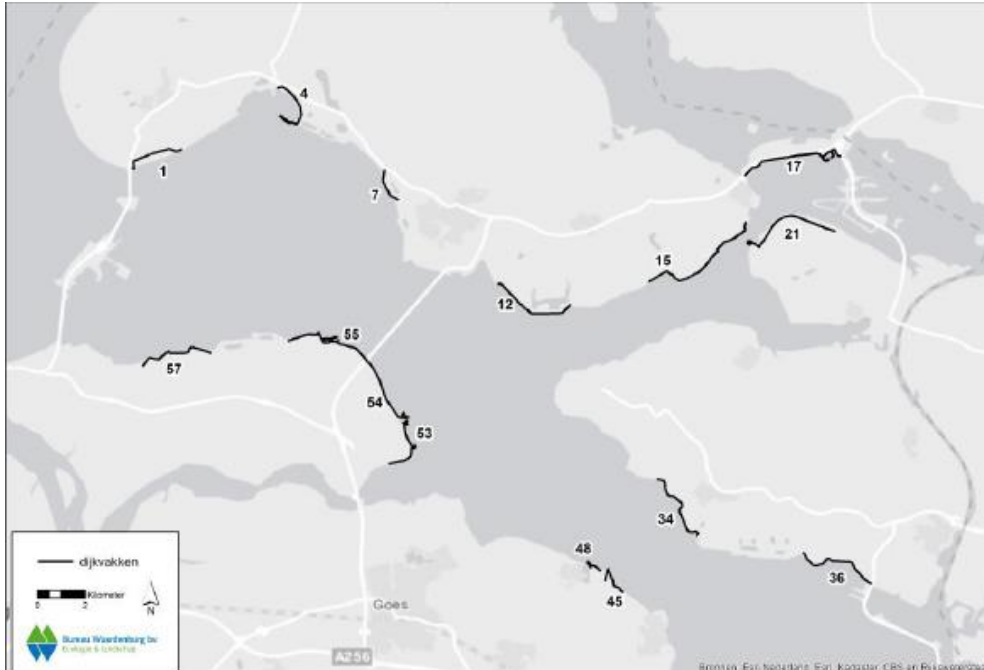
Figure 3.3 Monitored hard substrate along the Eastern Scheldt coastline in 2012 (Meijer & Didderen, 2012)

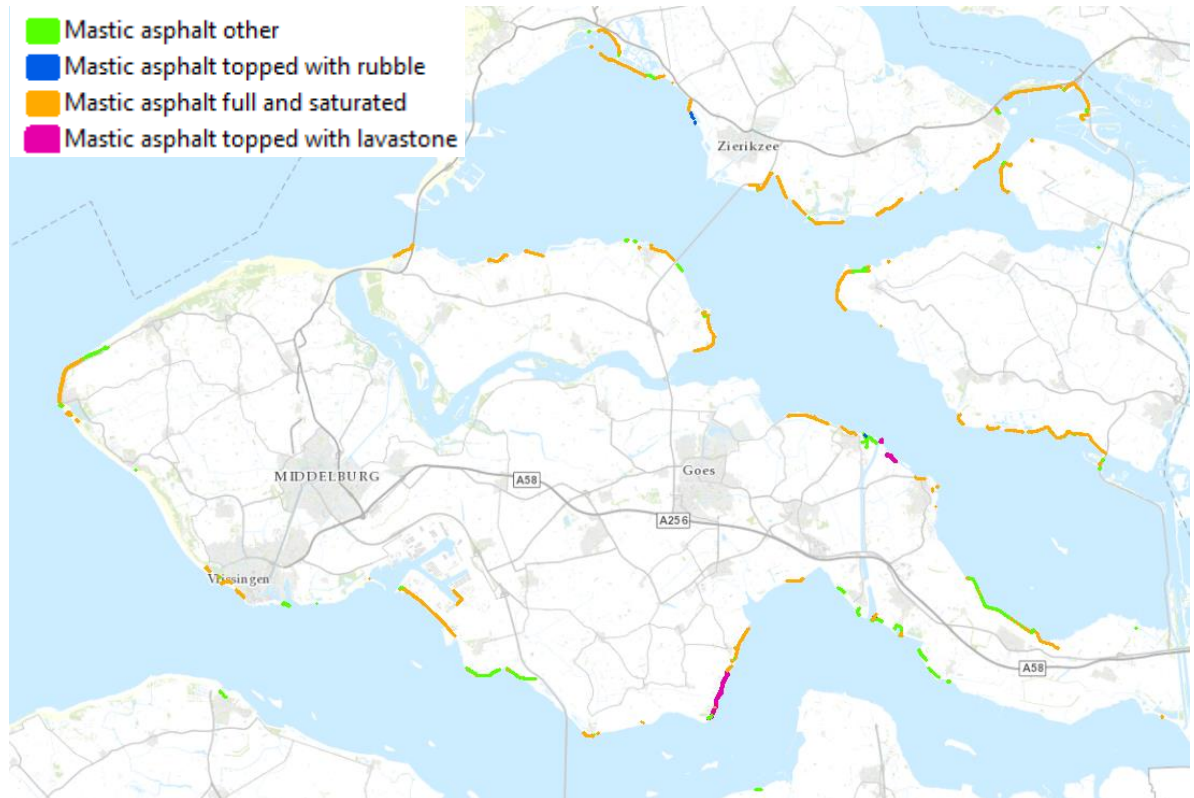
Figure 3.4 Selection of revetments along the coasts of Zeeland in the maintenance area of the water board: overview of known mastic asphalt locations in Zeeland (map adjusted from map by Scheldestromen).

Mastic asphalt has been applied on many locations along the coasts of Zeeland (Figure 3.4). Mastic asphalt itself is not thought to provide a suitable habitat for many weeds due to the suboptimal environmental conditions it provides such as a high temperature and a slippery surface. However, it can often be the only option from a safety perspective (M. Meijer et al., 2011). This is in part due to the sometimes limited period of time that revetments can be placed due to storm safety measures (April 1<sup>st</sup> to October 1<sup>st</sup>) and breeding season which overlaps the safety period in part (Jentink, 2005).

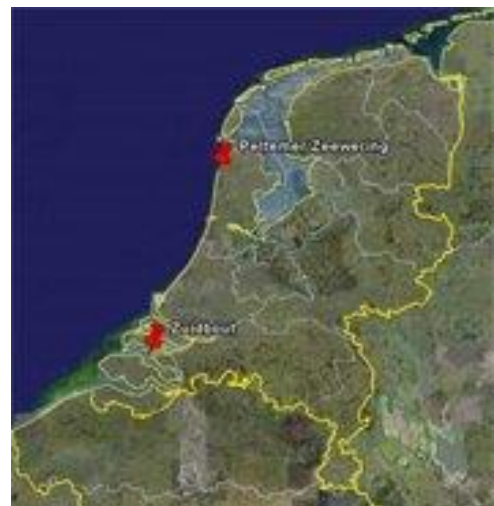
Figure 5.1 Elastocoast/PBA pilot locations at Petten and Zuidbout.

Elastocoast is a brand name for Polyurethane Bonded Aggregate (PBA) material that has been applied in a couple of pilot locations in the Netherlands, among which the Zuidbout in Zeeland and in Petten (Lock, 2008). Furthermore, it is being used along the shores of the province North-Holland to expand the feeding area for certain species of birds as a compensation measure for the new dunes that are being installed (expert judgement). The material has been designed in Germany by BASF and is a relatively new coastal protection material that is made of a combination of stones coated with polyurethane (Lock et al, 2008). Generally PBA or Elastocoast is made off of basalt stone or granite bound with a sort of “glue” called polyurethane, resulting in a porous but flat material that was designed to optimally handle wave pressure (Lock et al, 2008).
