Datum : 7 januari 2008  
 Projectnummer : 0703394  
 Referentie : c080045/ov/maw  
 Onderwerp : Rapportage GPR-metingen Muraltmuren te Viane en Schelphoek West

**MURALT WALLS:  
VIANE AND  
SCHELPHOEK,  
NETHERLANDS.**

GPR Investigation of  
Voiding below the  
Muralt Walls.

**FINAL REPORT**

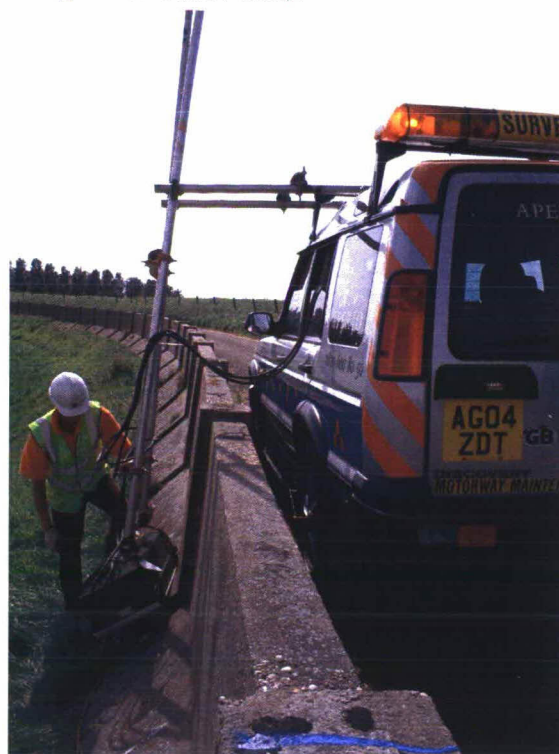
**Figure 1:** Survey Setup.

Access to all areas was from a Land Rover. The survey equipment was installed in a sledge which was attached to the survey vehicle by means of a fixed scaffold frame (figure 1). This allowed the sledge to be kept at a fixed position for the duration of each profile. The GPR recording equipment was operated and powered from the Land Rover and connected to each of the antennae by 9 m cables enabling access to all required areas.
