Eelgrass restoration in the Dutch Wadden Sea

Results 2014

1203892-000

1203892-000-ZKS-0044

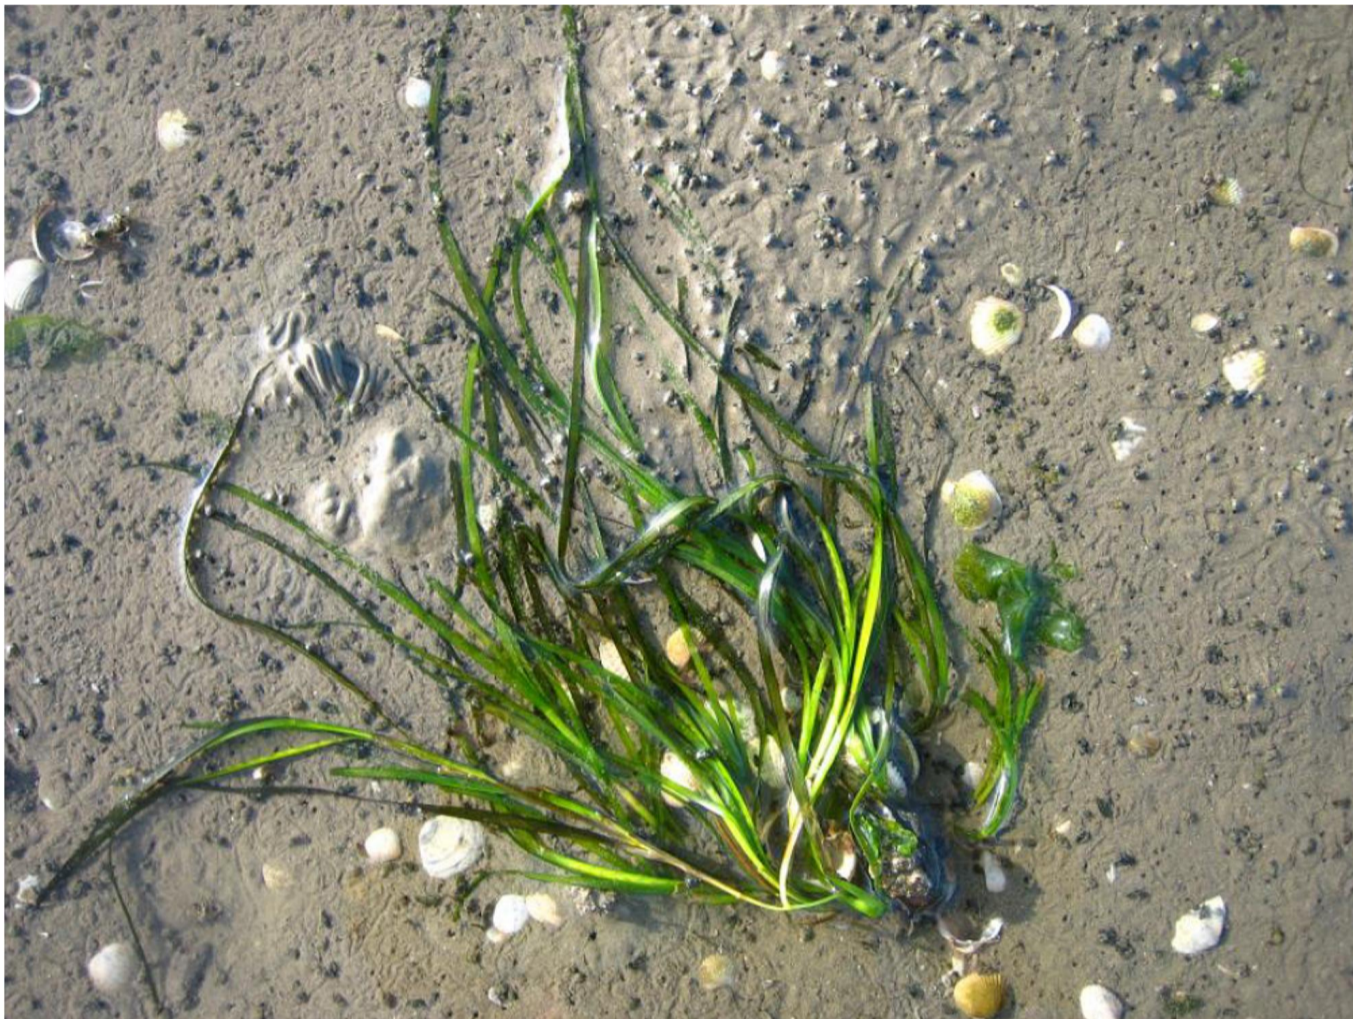
Figure 4.3 A: Uithuizen, 2014, Plants looked healthy and vigorous, despite the relatively small size most showed healthy seed development. Photo: Tolman & Pranger

All plants looked healthy, although relatively small, 15-40 cm in length (Figure 4.3). Most plants showed inflorescences with signs of seed development.

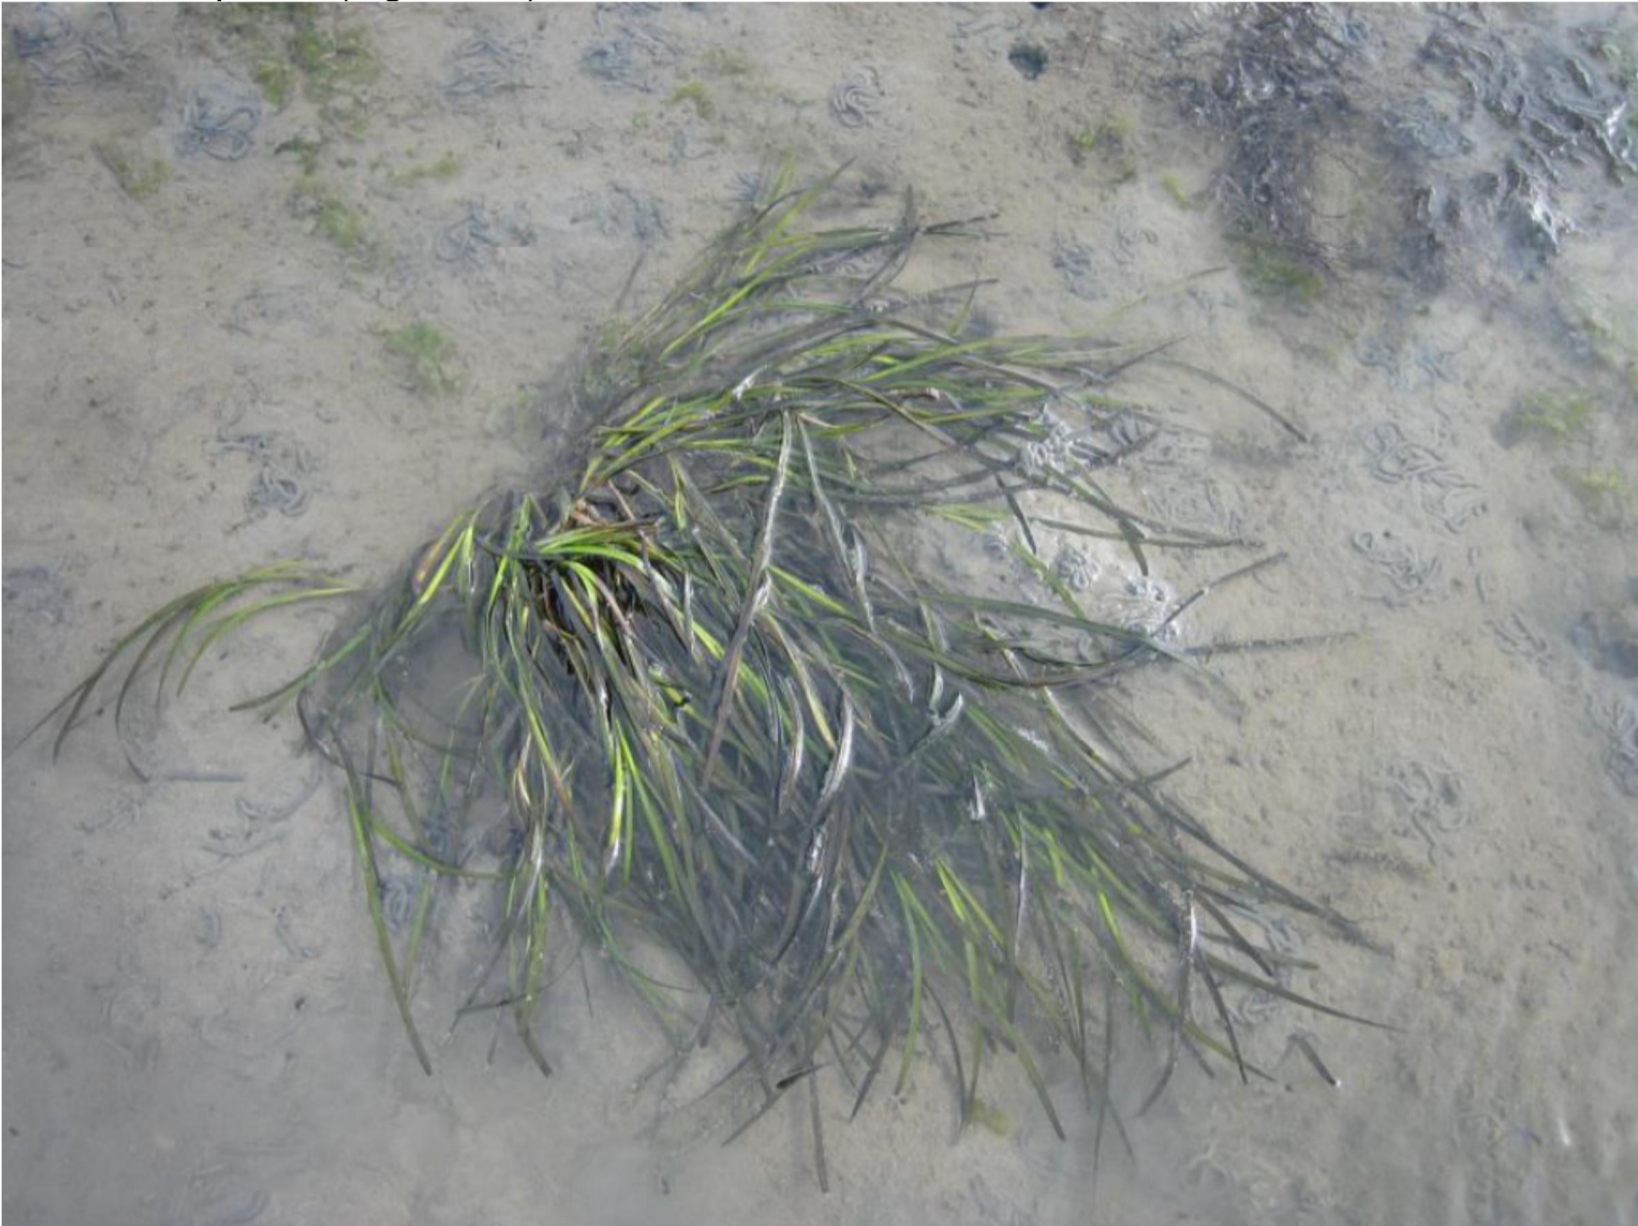
Figure 4.6 On Balgzand Eelgrass often shows discoloured patches. This site is characterised by large amounts of algae that sometimes tend to smother the eelgrass plants. Photo: Tolman and Pranger.

As in previous years, plant vitality varied considerably on this location. Generally plants were smaller than 40 cm in length. Mid-August many plants did show inflorescences and onset of seed development (Figure 4.6).

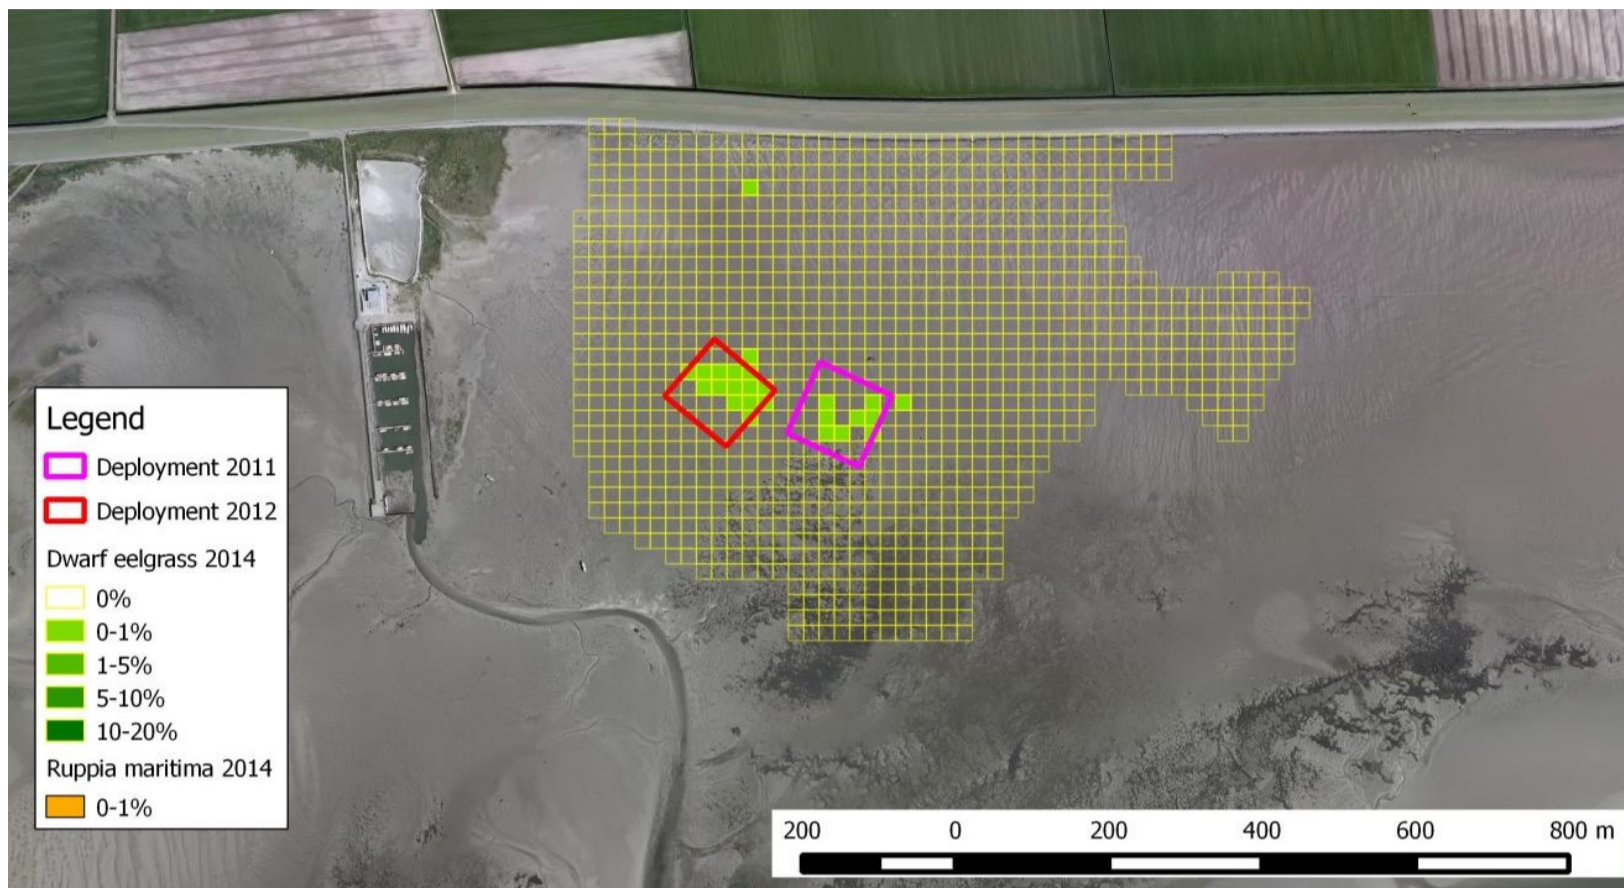
Figure 4.8 Distribution of dwarf eelgrass on Schiermonnikoog in 2014

Also in 2014 this species was observed, partly in the same location as in 2013, but curiously this year also within the perimeter of the 2011 deployment, where no dwarf eelgrass was observed previously (Figure 4.8).

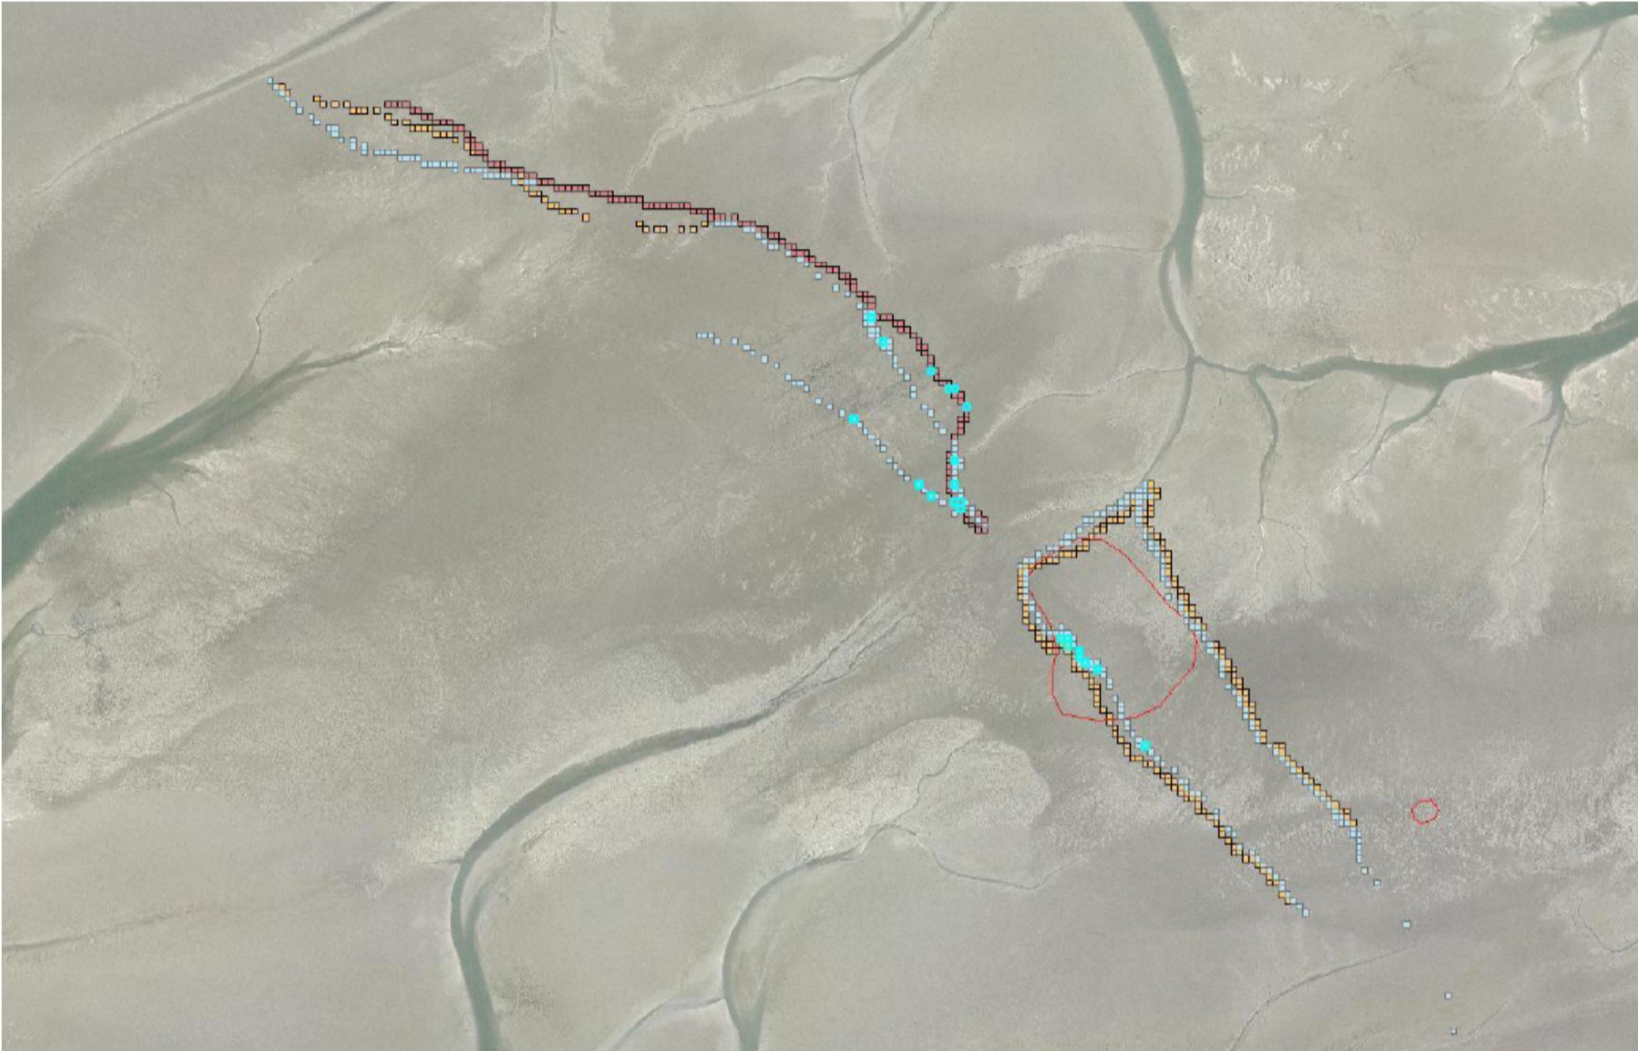
Figure 5.1: Detail of the surveyed area in 2014 with the cyan coloured points indicating the presence of eelgrass plants. Red circles indicate the location of eelgrass in 2013.

In total 3689 cells were surveyed, of which 25 contained eelgrass plants. The distance between the plants in this area was large and this site does not constitute a coherent meadow, like it appeared to be in 2013.

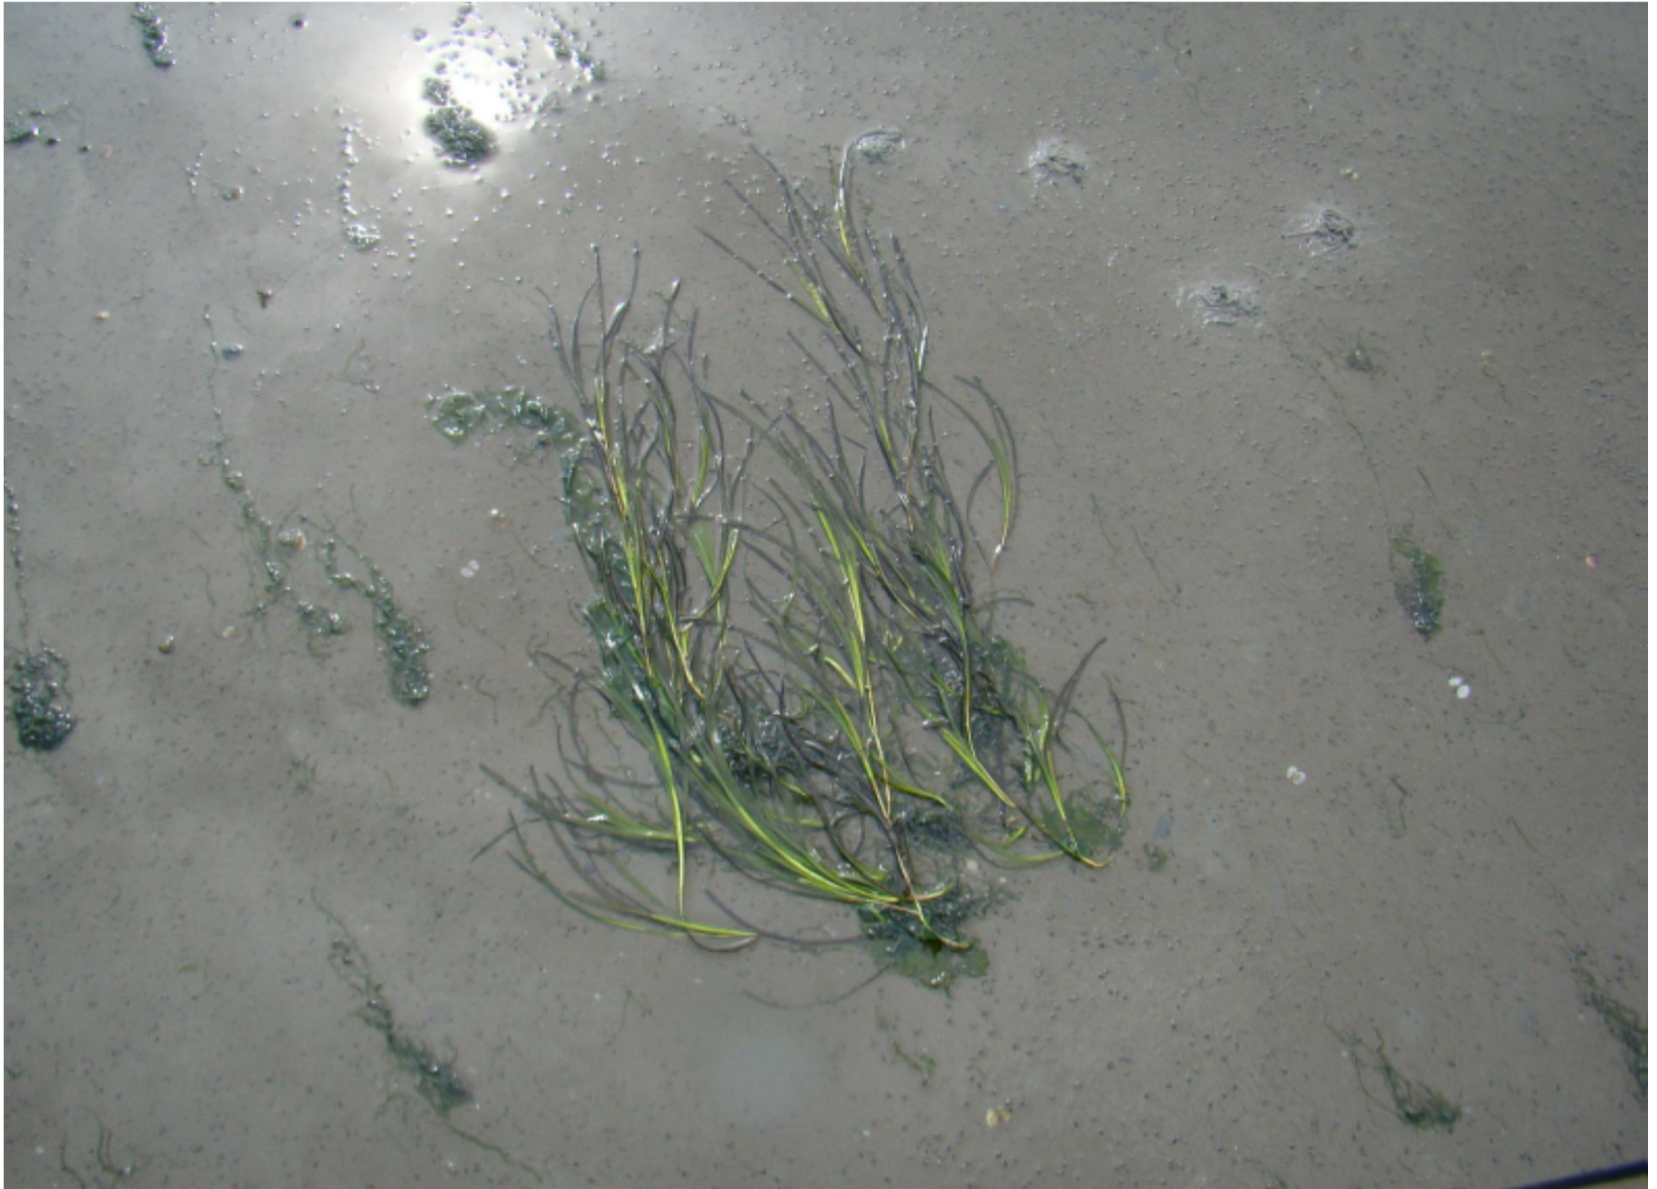
Figure 5.2 Plants with inflorescences at EB7 buoy, photo RWS-CIV

The plants appeared healthy, with dense leaves, and nearly all plants showed seed development (Figure 5.2). Most plants ranged around 20-30 cm, while the largest ones reached up to 60 cm. This appeared to be smaller than the plants that were observed in 2013. Some seed development was observed.

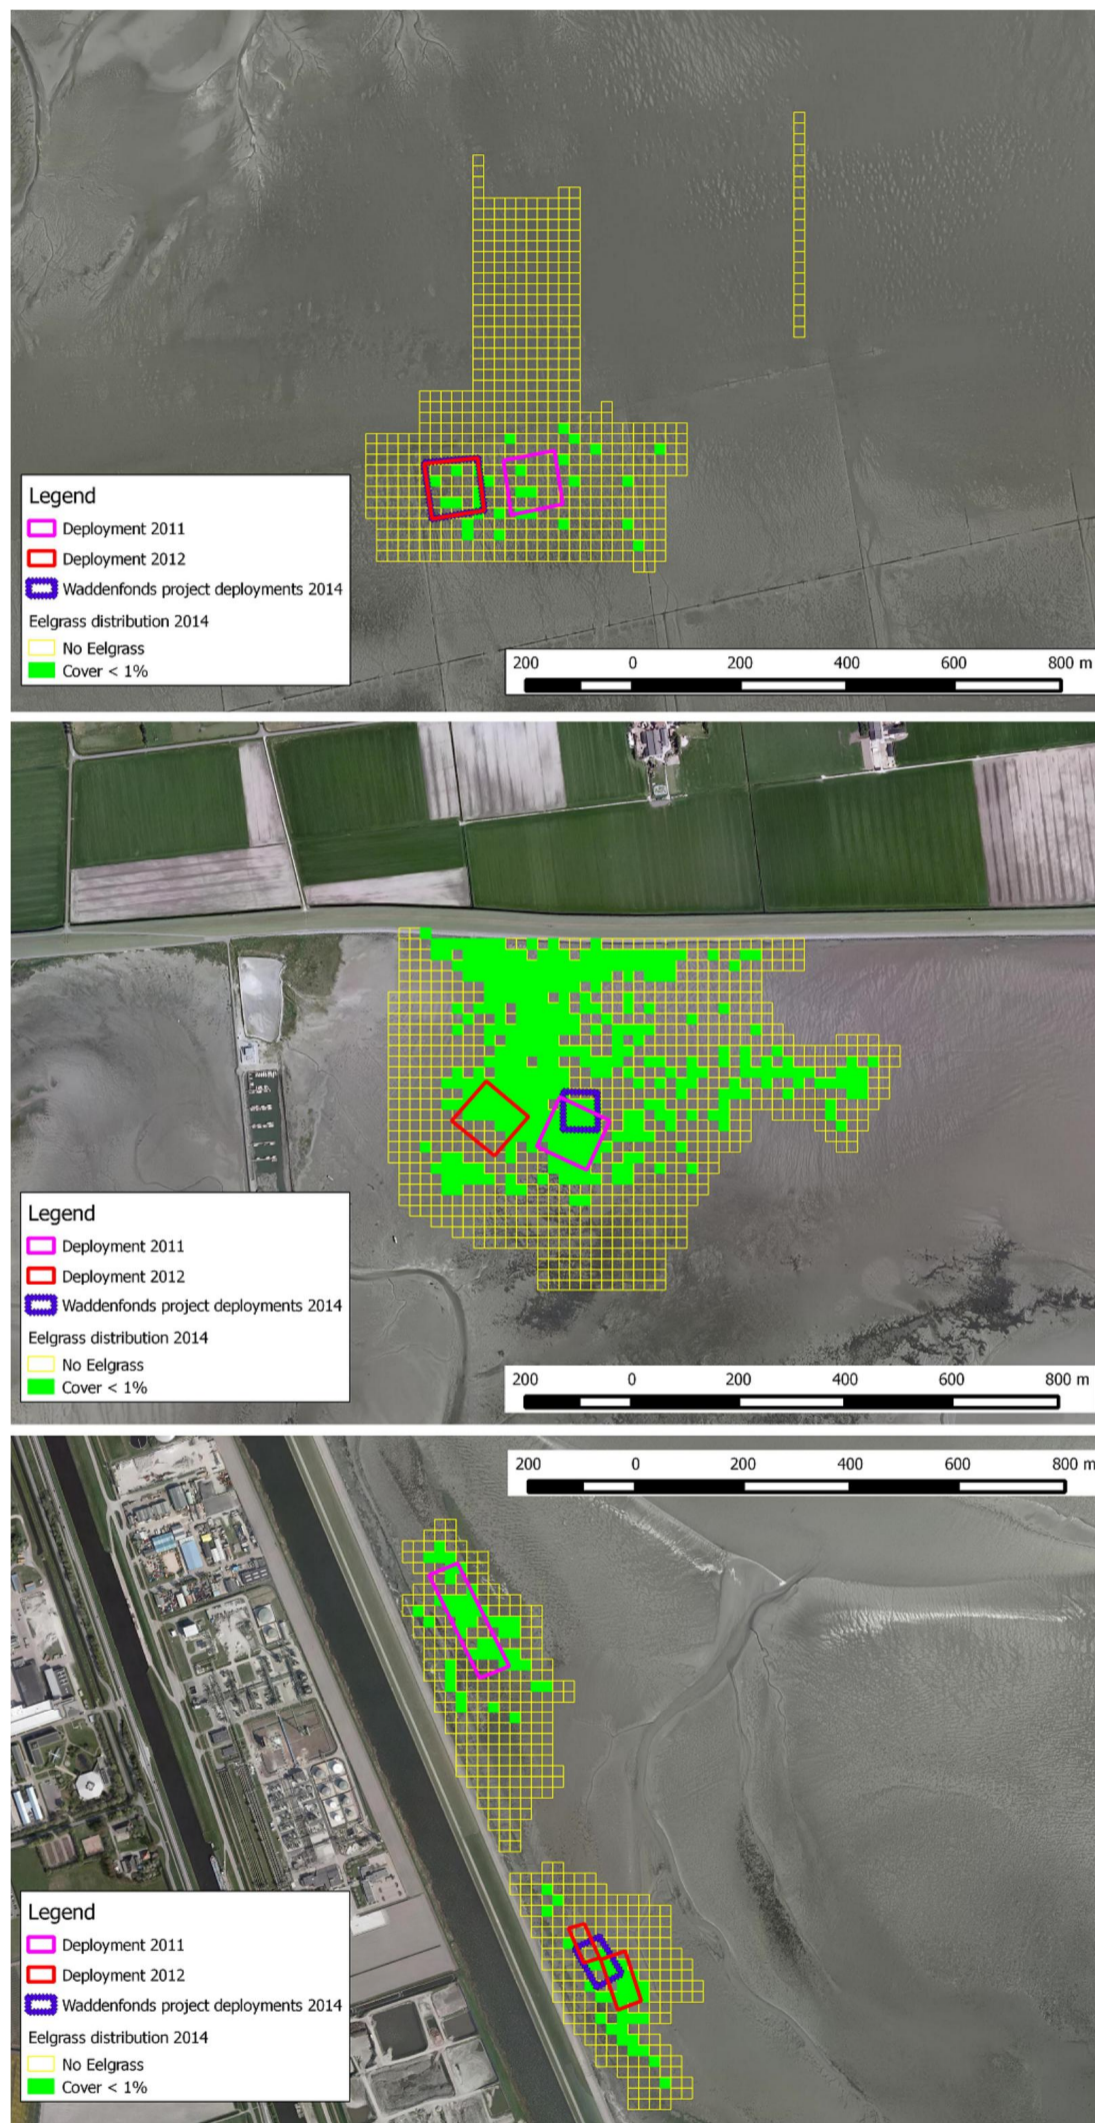
Figure 6.1 Locations of the 2014 deployments of the Waddenfonds project in relation to the 2011 and 2012 deployment sites and the 2014 distribution of eelgrass. Note that the boundaries of the 2012 and 2014 deployments at Uithuizen overlap virtually completely, leaving the 2014 marking obscured.

The initial success of this project has received a lot of attention and there are a number of initiatives and ideas among NGOs and managing authorities (national and local) to expand the restoration effort to other areas. In 2014 a consortium of NGOs has received a grant from the “Waddenfonds” for additional restoration efforts in the vicinity of the current deployments. Their 2014 deployments coincided with the 2012 deployment sites for Balgzand and Uithuizen, while on Schiermonnikoog the location is in the 2011 deployment site (Figure 6.1).
