Eelgrass restoration in the Dutch Wadden Sea

Results 2013

1203892-000

| Rijkswaterstaat - WVL | 1203892-000 | 1203892-000-ZKS-0040 | 19 |

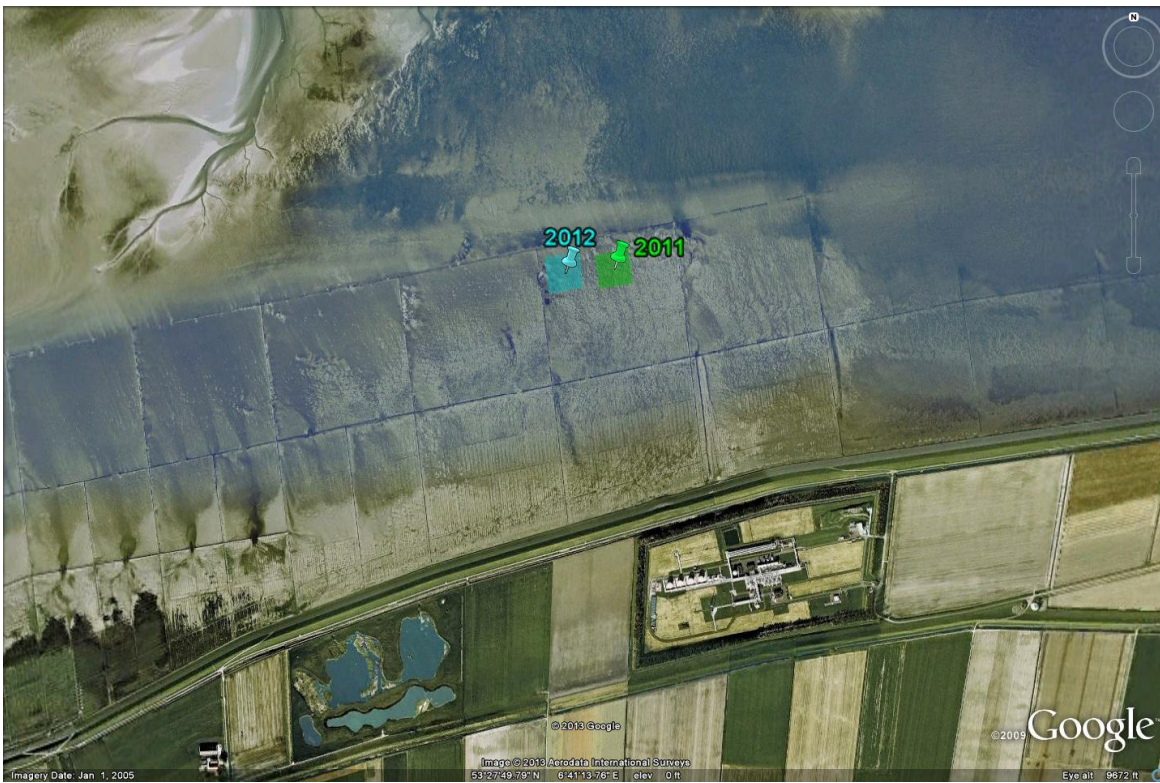
Figure 2.1: Locations at near the Saltmarshes in North Groningen. The green square indicates the 2011 deployment location, the light blue square is the deployment location used in 2012.

Near Uithuizen the 2011 a location site was selected 100 m long and 100 m deep (running parallel to the saltmarsh land reclamation plots). The centre of the 2011 plot was: N 53°28'02", E 6°41'17".

The choice for the 2012 deployment site was just west of the 2011 site: close to the original one and with limited chance of trampling emerging eelgrass plants. The centre of the 2012 plot was: N 53°28'01.92", E 6°41'10.41".

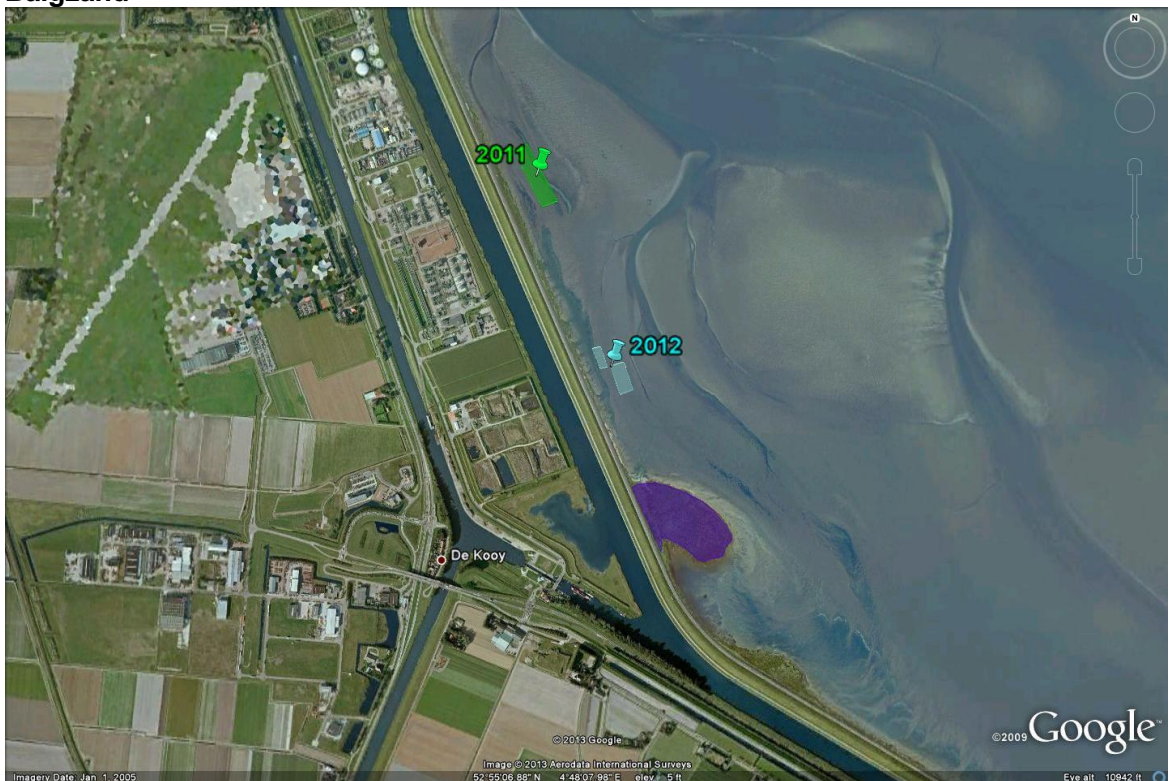
Figure 2.2: Balgzand deployment locations, the 2011 area is indicated in green, the 2012 deployment is indicated in light blue.

The 2011 plot at Balgzand was 250 x 40 metres and the centre was located at N 52°55'30" and E 4°47'59". For 2012, a deployment location slightly further south was selected. Due to local topography (the presence of a small gully in this area, the 2012 location was split into two adjacent sections, the total surface area remained 1 Ha. The centres of the two rectangles were located at: N 52°55'11.28", E 4°48'10.20" and N 52°55'09.05", E 4°48'14.18" respectively.

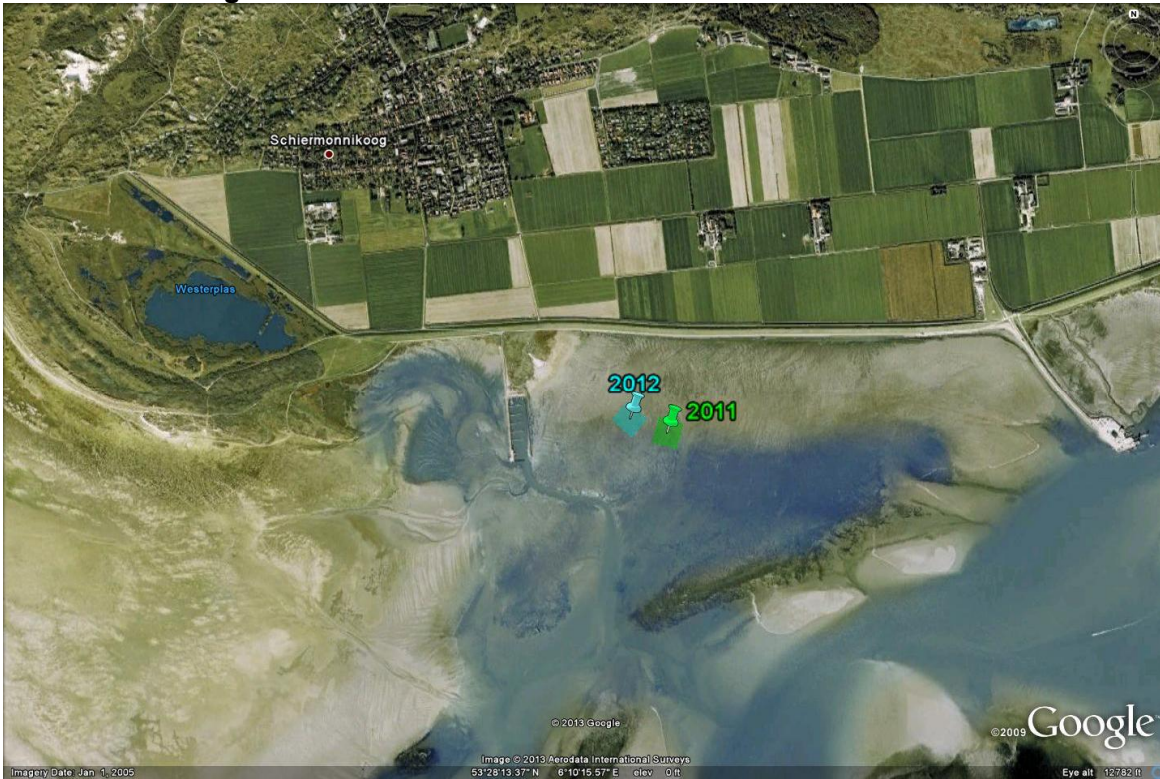
Figure 2.3: Schiermonnikoog locations. The 2011 is indicated in green, the 2012 location in light blue.

The 2011 location at Schiermonnikoog was square (100 x 100m) with the centre at N 53° 28' 08" and E 6° 10' 33".

In 2012 most eelgrass appeared to the north of the 2011 location and changes appeared to have occurred with respect to sediment composition and elevation. Based on the occurrence of eelgrass and local bed elevation the 2012 location was situated a little closer to the dike, with the centre at N 53° 28' 10.22" and E 6° 10' 24.75".

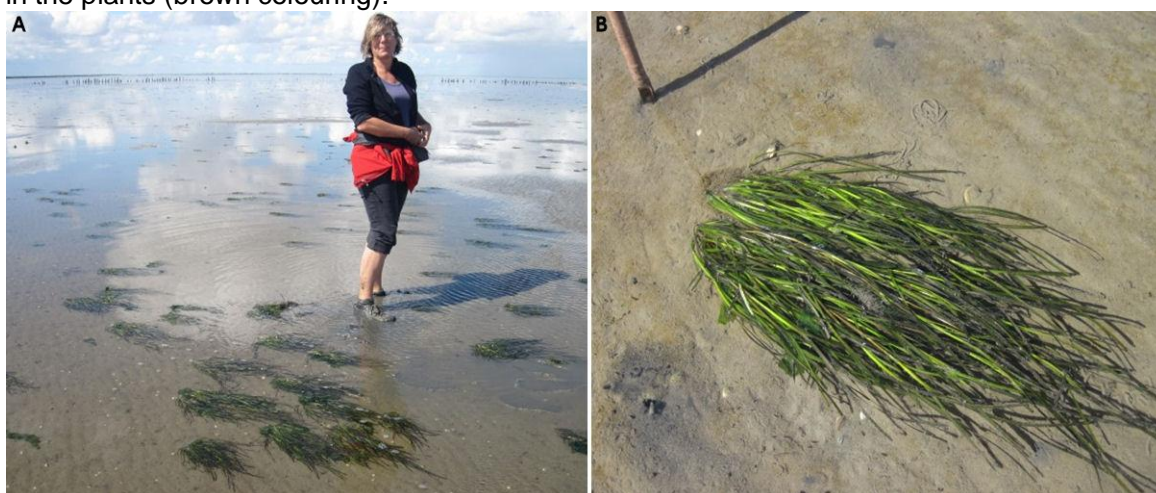
Figure 4.2 A: Uithuizen, 14 August 2013, locally high plant densities, B: Plants looked healthy and vigorous, although closer inspection revealed that flowers seemed to decay before seeds were ripe. Photos: Marieke van Katwijk.

All plants looked healthy, ranging in size from 20-70 cm (Figure 4.2). Early August plants were still flowering and little evidence of seed development was seen. Late August the presence of seed was recorded, and early September there were clear signs of senescence in the plants (brown colouring).

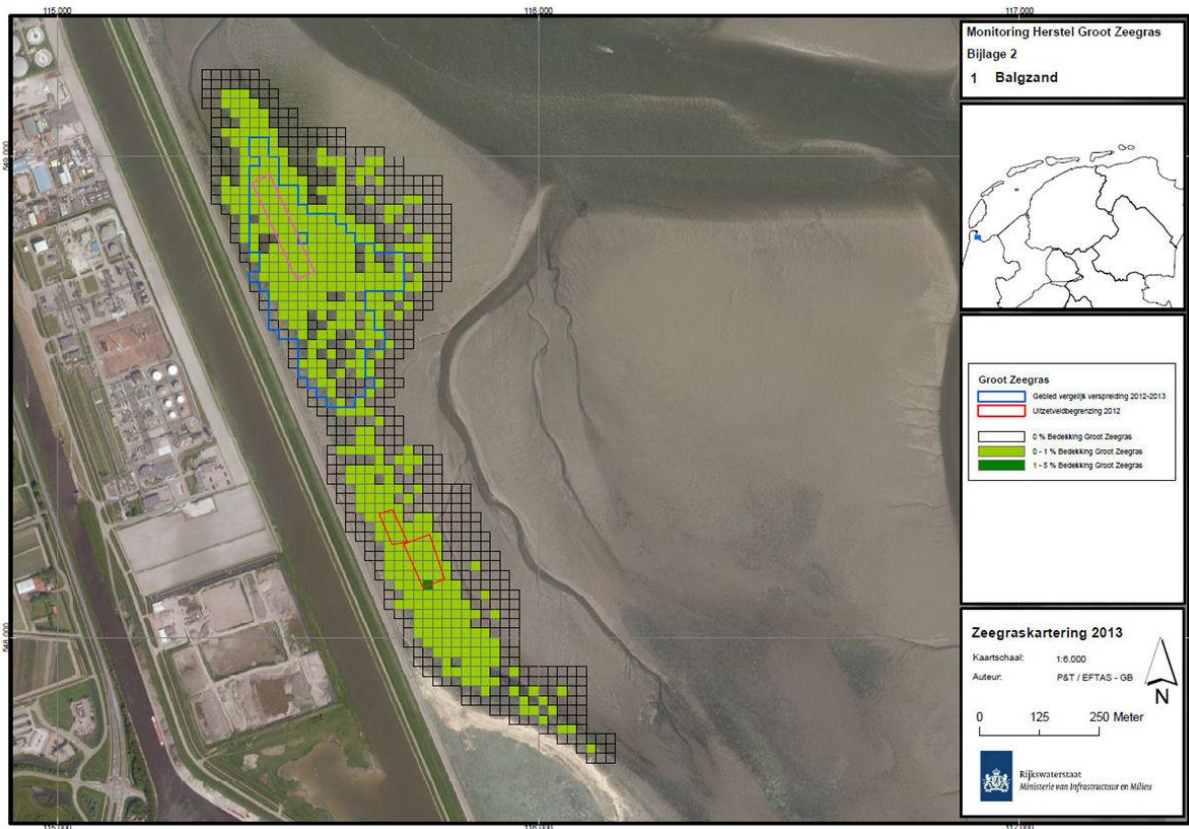
Figure 4.3: Surveyed area on Balgzand. Light green patches represent 0-1% cover; darker green represents 1-5% cover. The blue line indicates perimeter of the extent of the eelgrass cover in 2012. The red box indicates the deployment locations of 2012, pink represents the 2011 deployment.

The distribution of eelgrass on Balgzand is shown in Figure 4.3. There are clearly two centres with high distributions, corresponding to the deployment locations in 2012 and the one from 2011. Although there are sporadic observations of individual plants between the two areas, the density in the area halfway between the two successive deployments is very low.

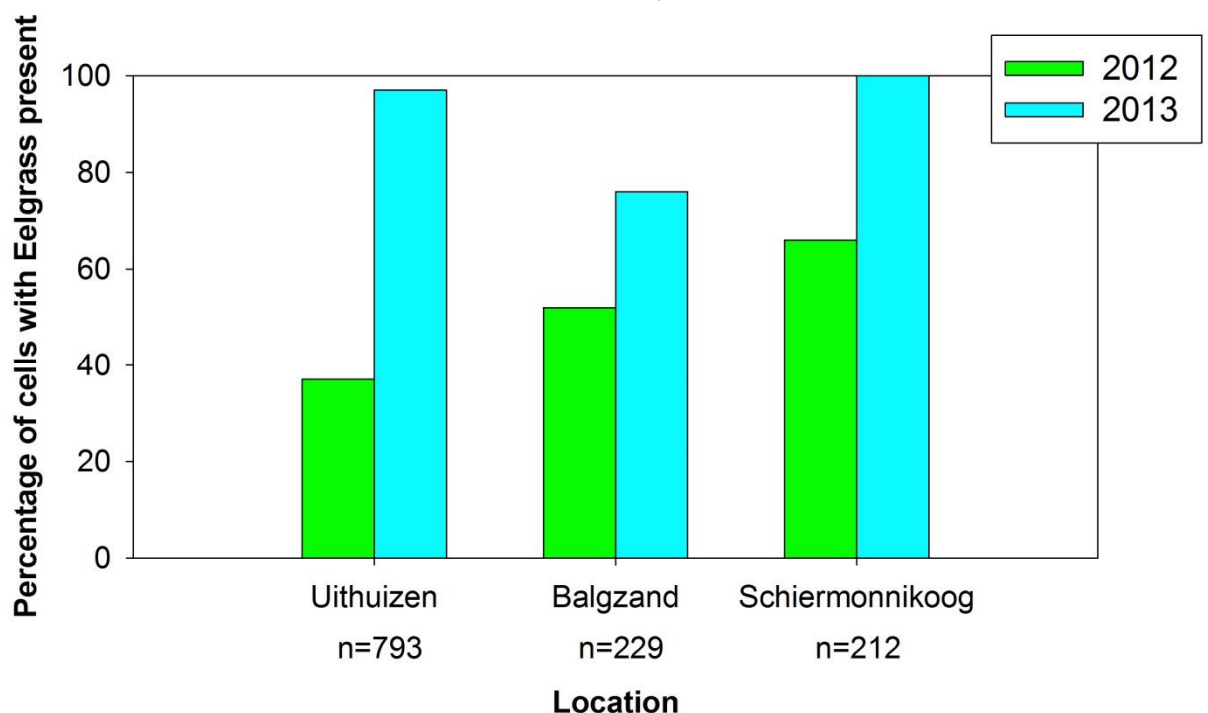
Figure 4.7: Comparison between 2012 and 2013 in terms of proportion of cells containing eelgrass; 100% being the total number of cells surveyed in both 2012 and 2013.

Figure 4.7 shows that there is a clear increase in all three locations, indicating that the cover in 2013 was less patchy than in 2012. Particularly for Balgzand this is remarkable, as on this site, the 2011 and 2012 deployments were several hundreds of metres apart. Here, the increase is therefore likely due to an expansion of the 2011 population, rather than an influence of the remote seeding from the 2012 deployment.

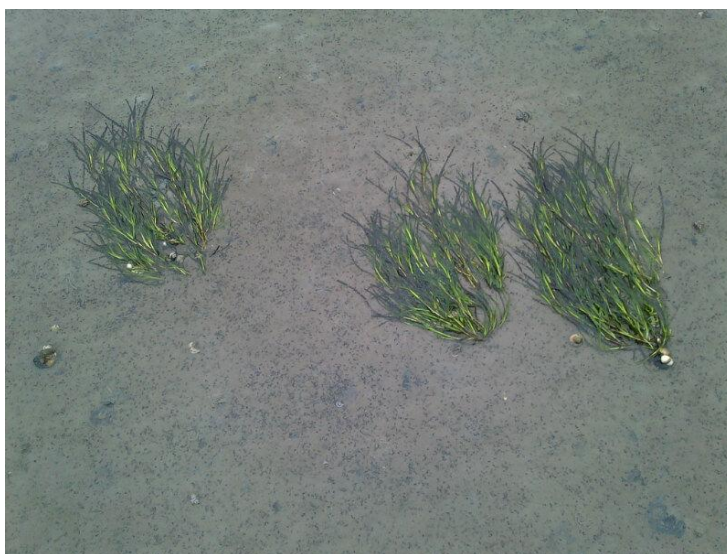
Figure 5.3: Plants with inflorescences at EB7 buoy, photo RWS-CIV

The plants appeared healthy, with dense leaves Figure 5.3. Smaller plants were ranging between 10 and 15 cm, the largest ones reaching up to 1m. Some seed development was observed.

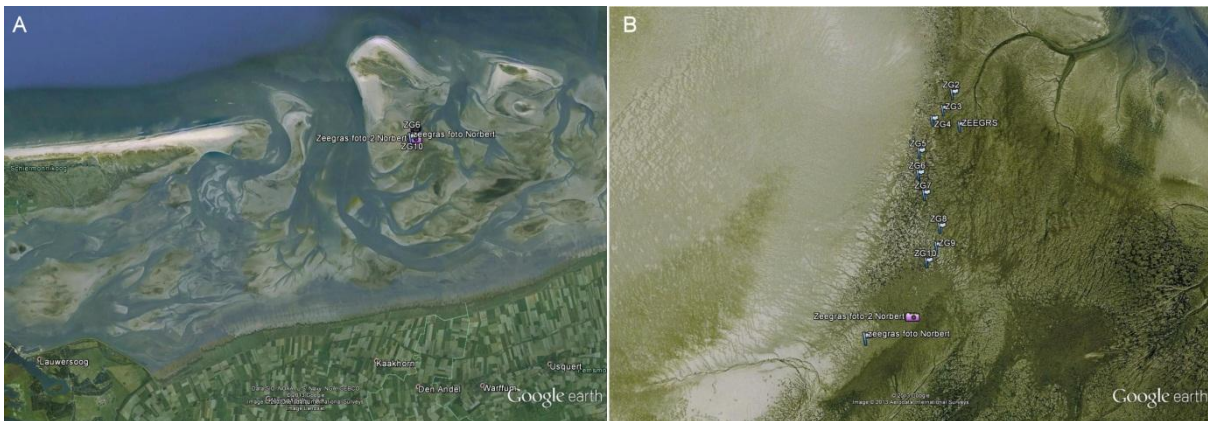
Figure 5.4: Locations of observed plants on Rottum

Several plants of *Z. marina* were observed on the 25th of September 2013 at Rottum by a group of researchers from IMARES. The plants were on average 20-50 cm in size and appeared healthy. They also contained ripening inflorescences. The locations of some individual plants are indicated in Figure 5.4.

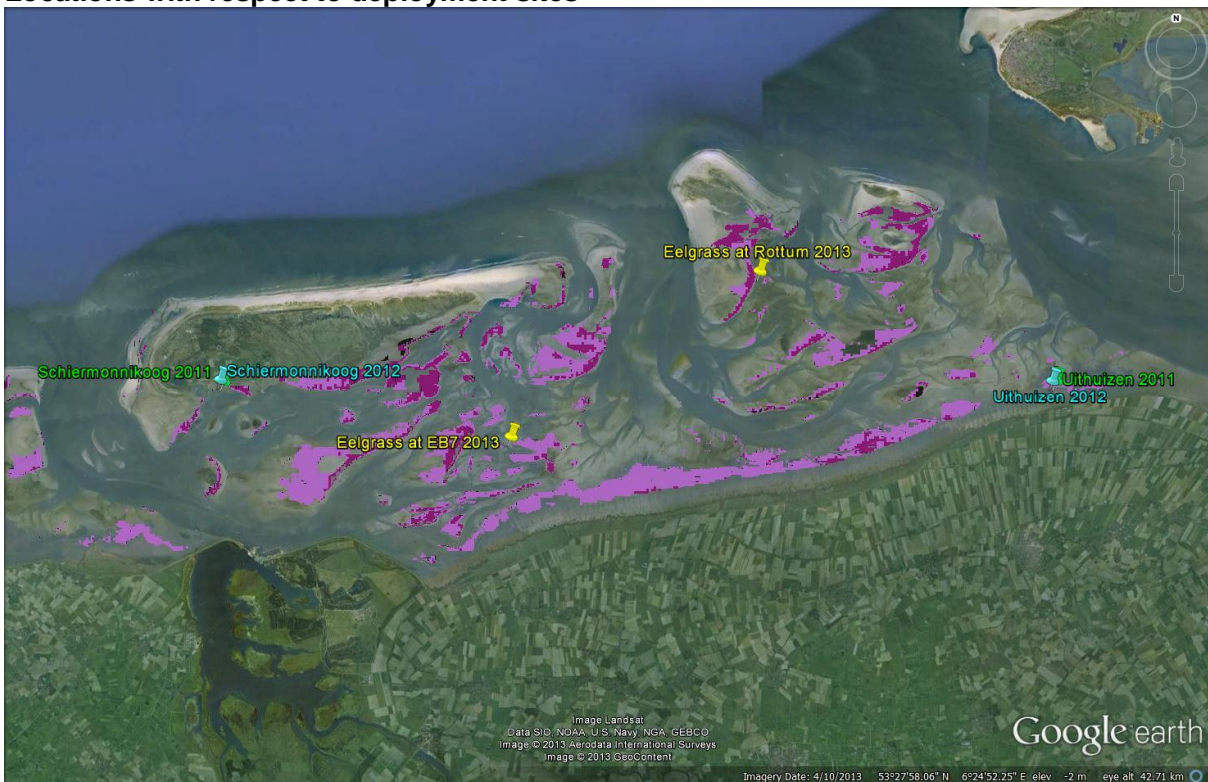
Figure 5.5: Two "new" eelgrass locations with respect to the two nearest deployment locations and with the habitat suitability map plotted in the background. Purple colours indicate locations that are on the basis of models and expert judgement deemed to be suitable for seagrass.

Both reported 'new' eelgrass sites are located between the Uithuizen deployment and the Schiermonnikoog deployment. Both sites are also very near sites that were identified in 2006 as "suitable or partially suitable for eelgrass"(De Jong et al. 2005).

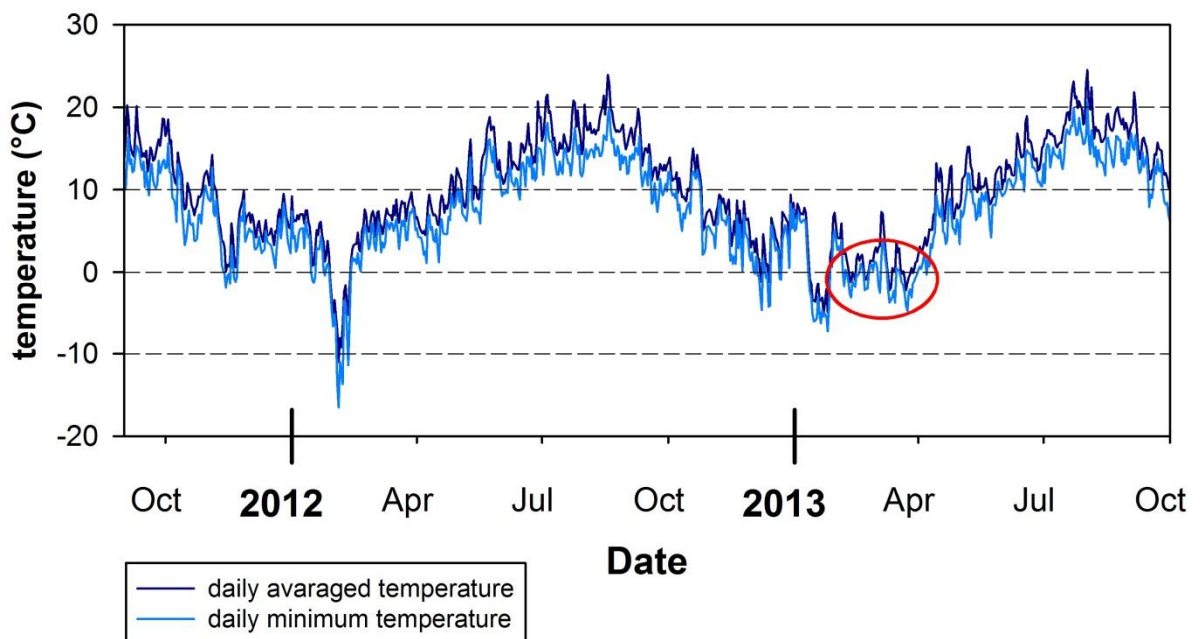
Temperature record Lauwersoog

Figure 6.3: temperature record at Lauwersoog from 1 September 2011 – 1 October 2013; red oval indicates cold spell in spring 2013)

In 2012 there was a brief period with very sharp frost ($<-15\text{ }^{\circ}\text{C}$ for several nights) in February, resulting in ice floes. This cold spell only lasted a couple of weeks. The spring was mild and eelgrass developed relatively early in the Dutch Wadden Sea and also in the German Wadden Sea around Sylt (Karsten Reise pers. Comm). Although temperatures were not so extremely low in the winter 2012/2013, there was a very long protracted period of cold weather in spring. From mid-January until late March – early April, daily average temperatures ranged around freezing point and night time temperatures were rarely above freezing (Figure 6.3).

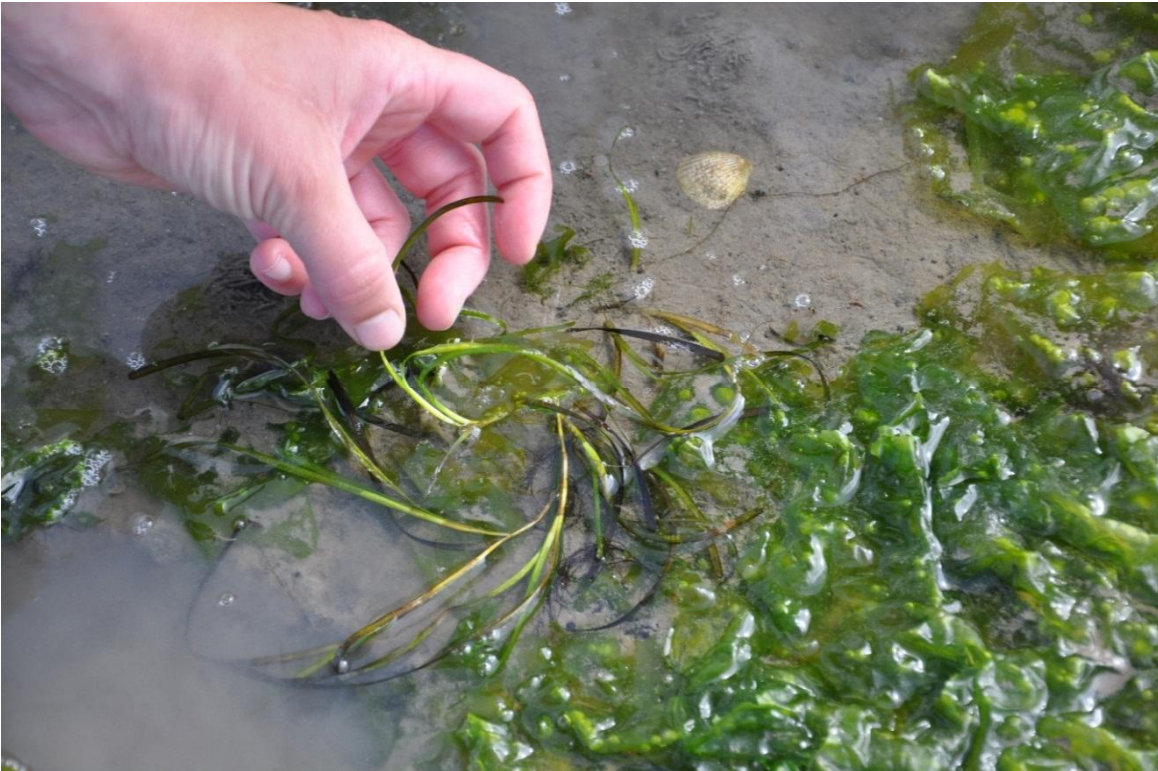
Figure 6.4: Picture taken on the 4th of September, eelgrass flowers on a plant showing signs of decay. Photo: Luca van Duren; see also similar pictures in section 4.

During visits in Augusts to Uithuizen en Schiermonnikoog and during a visit in September to Balgzand several plants were observed to still have flowers, rather than inflorescences with seed. Older flowers seemed to decay rather than develop seed. During these visits, very few male flowers were encountered, although no quantitative observations were made on the sex-ratio of flowers. It is possible that many flowers remained unfertilised due to pollen deficiency, but this remains speculative. Very few well-developed inflorescences with (nearly) ripe seeds were seen.
