MURALT WALLS: VIANE AND SCHELPHOEK, NETHERLANDS

GPR Investigation of Voiding below the Muralt
Walls
for
KOAC NPC

Project Number 3067

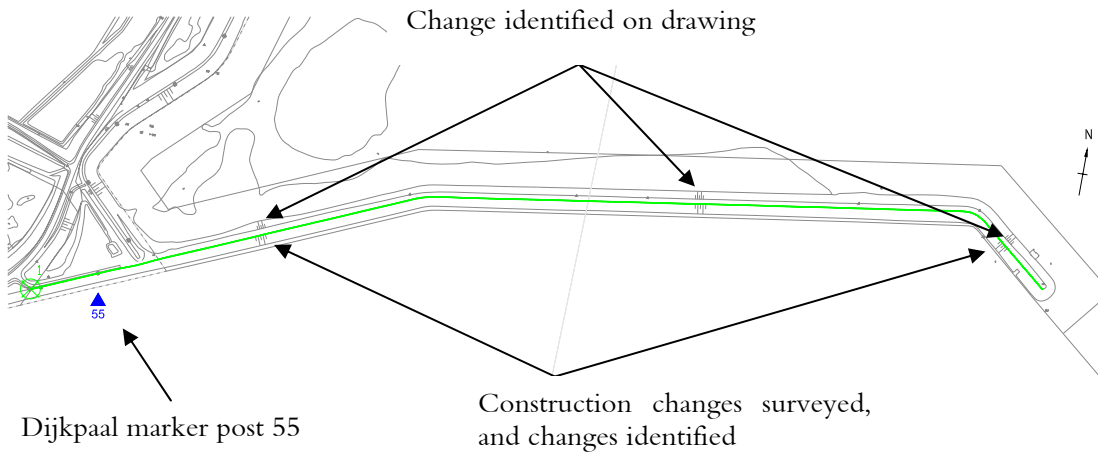
Figure 3: Location plan of Schelphoek West showing locations of construction changes. Green line represents survey area.

The drawing supplied by the client shows three changes in construction along the length of the survey area. Due to heavy vegetation on site, only two of these construction changes were surveyed, and changes in data were identified over both. It is therefore likely that the remaining unsurveyed construction change will be of similar construction to those already surveyed (Appendix A Figure 2). Plate 6, Appendix C shows an example of the surveyed construction change at Dijkpaal 55 +c.1327 m which was also visible on the surface.
