Evaluation of Fish Injury and Mortality Associated
with scale models of the
Pentair Fairbanks Nijhuis Modified Bulb turbine
and the
Water2Energy Cross Flow turbine

**Evaluation of Fish Injury and Mortality Associated
with scale models of the Pentair Fairbanks Nijhuis
Modified Bulb turbine and the Water2Energy Cross
Flow turbine**

Report number: 20140961/rap02
Status: Final report
Date: 1-9-2015

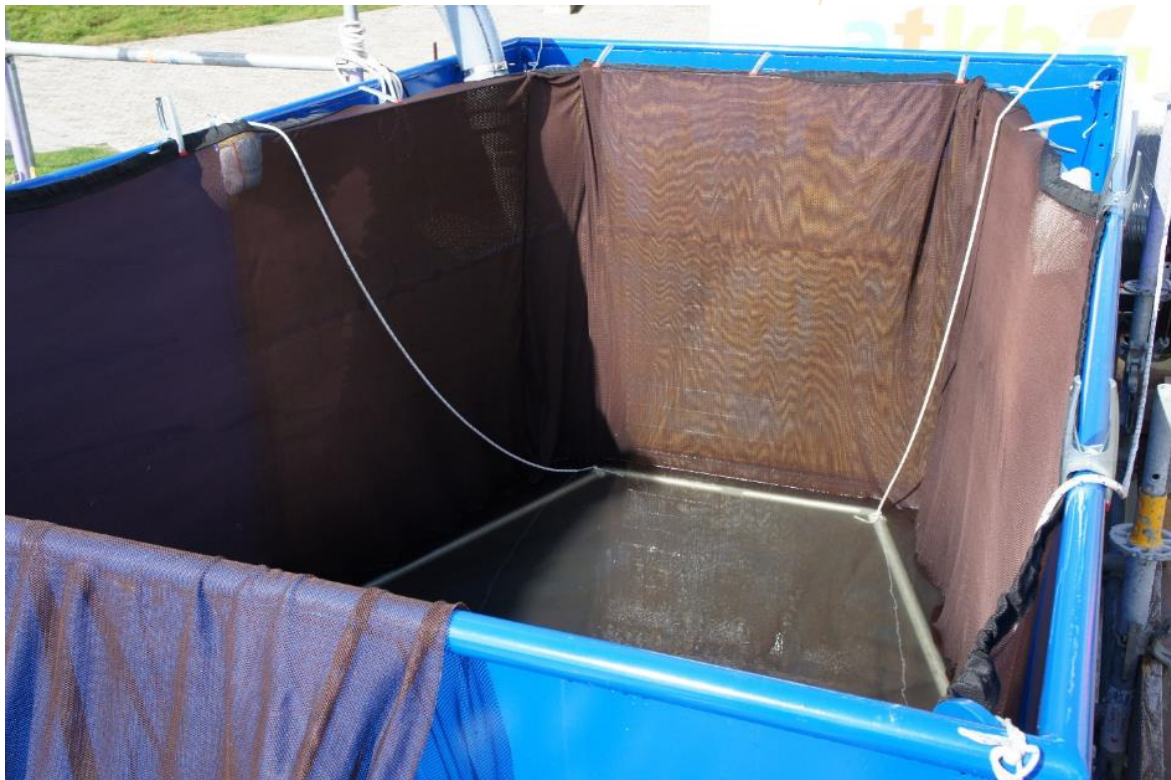
Figure 15. Low water tank with collection net for fish

A collection net was used in the low water tank to prevent fish from escaping to the river. A heavy frame prevented the net from moving to and fro and thus possibly damaging the fish. Fish could escape to the river through a small opening below the baffles, hence the collection net was necessary. The net was not necessary for removing the fish because it turned out to be just as easy to go into the

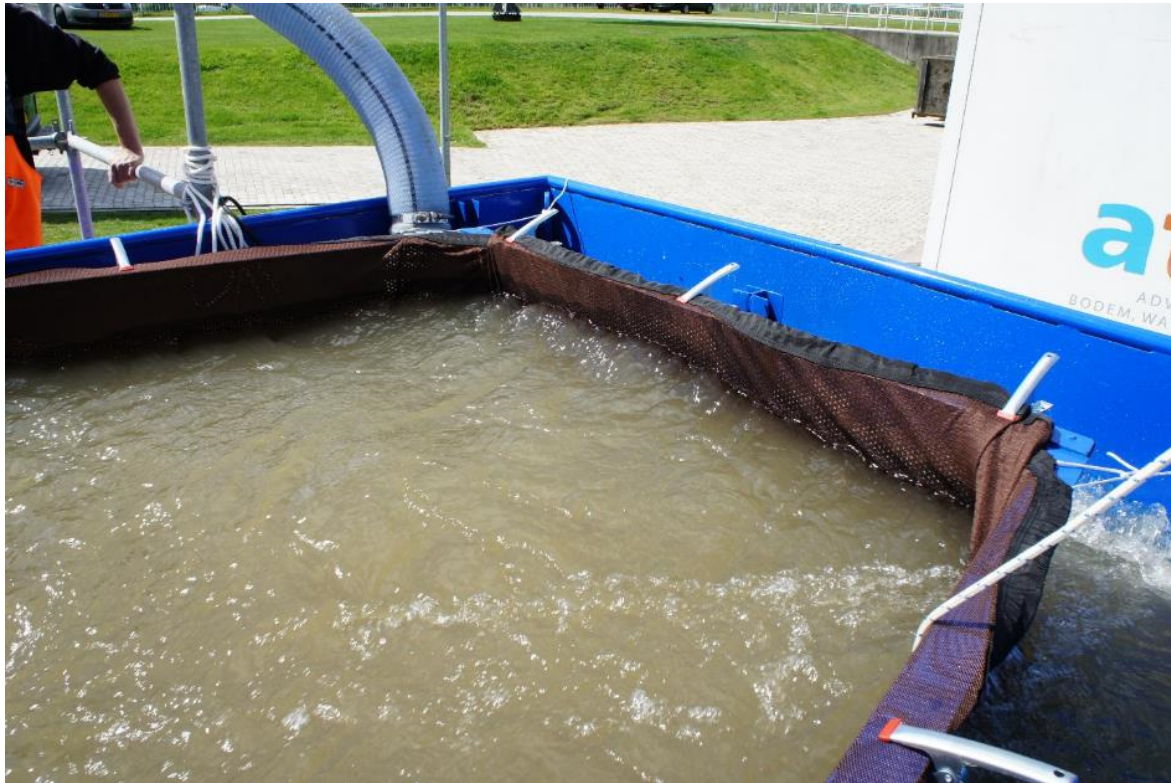
Figure 16. Water flow in low water tank

tank (when the water was drained) and remove the fish one by one using a small hand held dip net, thus treating the fish with utmost caution. When fish had passed through the turbine and entered the low water tank they directly displayed controlled swimming and schooling behavior. Fish seemed not to be disoriented in any way. The turbulence in the low water tank was minimal, as can be seen in figure 16.

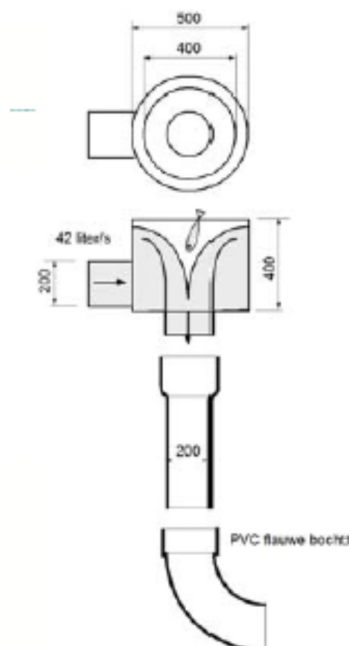
Figure 17. Intake structure for fish

The specially designed fish intake structure turned out to work very well (figure 17 and 18). The structure had its own water supply (42 l/s) by smaller pumps in the high water tank and in the low water tank. The water enters the top end of the structure and then flows over the edge into the funnel. Water with fish can be added from above and the constant flow takes the fish away down through the insertion pipe (diameter 0,2 m) in a very gentle way. The horizontal part of insertion pipe was actually somewhat longer than depicted in figure 17 and reached well into the large pipe leading to the turbine, to prevent fish from swimming back to the high water tank. The flow velocity in the insertion pipe and the large pipe was approximately 1,5 m/s, fast enough to carry the fish to the turbine. The distance from the insertion point to the turbine however, was long enough to give fish time to orientate themselves in the flow. From high speed camera footage it could be concluded that most fish, passing through the turbine, performed controlled swimming. Only very few fish succeeded in swimming against the current and reaching the high water tank.

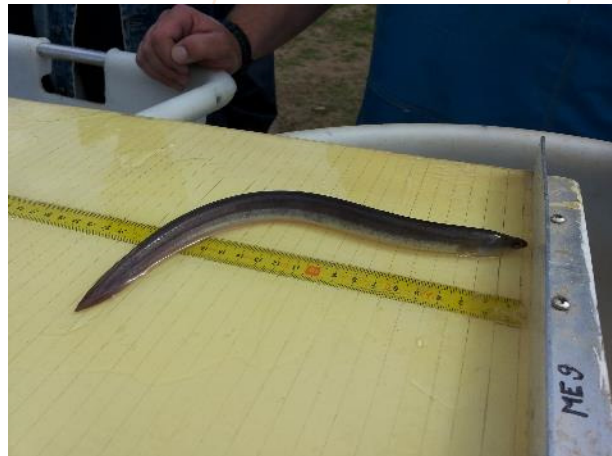
Figure 23. A perfectly healthy eel after testing

Test 3-1 did not result in any fatalities among the yellow eel. None of the eel suffered any damage. Mortality after 48 hours was zero.

Test 3-2 , under milder conditions, did not result in any fatalities. None of the eels were slightly damaged. Mortality after 48 hours was zero.

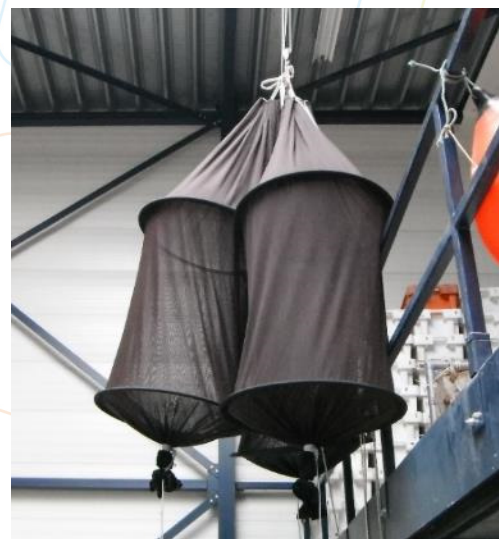
Figure 24. Vertical keep net for storage of fish

Insertion of fish in the test rig was very easy and fast. Water with fish could be dosed perfectly and the transport of the fish through the turbine into the low water tank only took seconds. As it turned out, the dimensions of the collection net was not in accordance with the actual size of the low water tank. This proved not to be a great set back as adaptations could be made on site. After the test and collection of the fish from the low water tank, fish were slightly anaesthetized and checked for damage. All damaged fish were photographed. After this procedure fish were stored in vertical keep nets attached to a line with floating buoys (see figure 24). When the experiment had ended, fish were released on site.

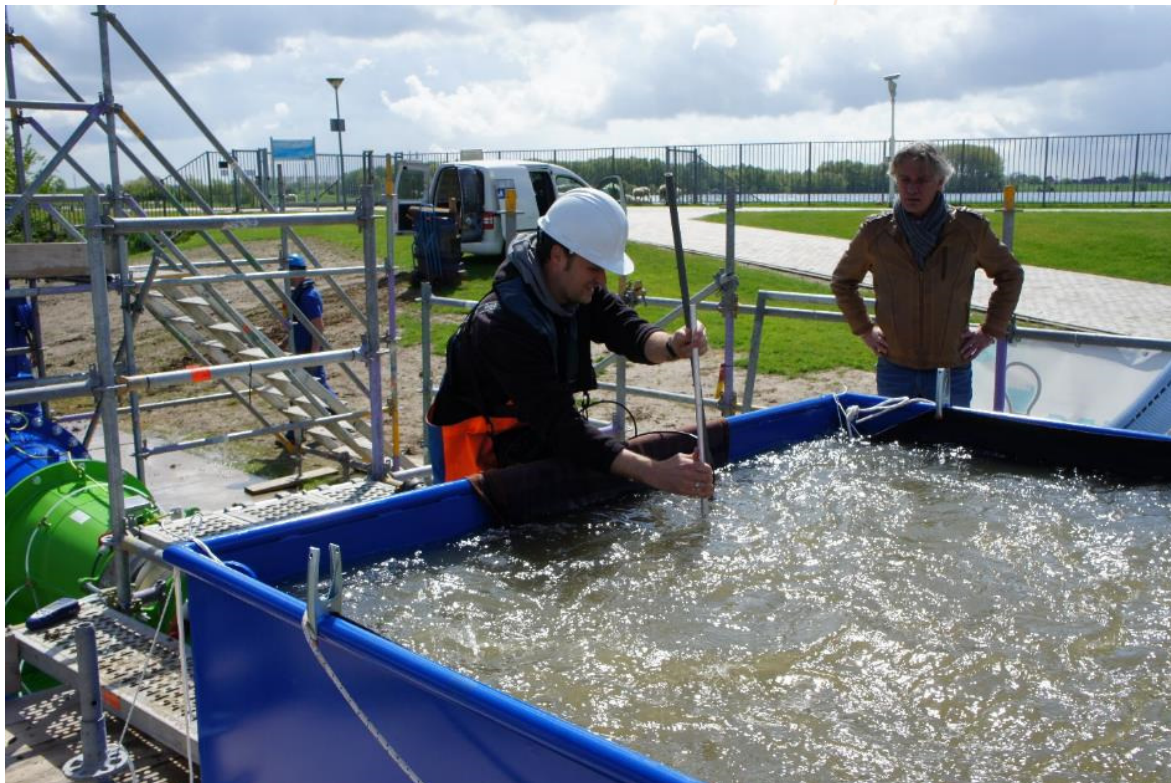
Figure 25. Measuring the water flow coming out of the large pipe with a Flow Mate 2000

The design of the test rig functioned very well. The large pump supplying the water for the test rig had enough capacity. The high tank could be filled to capacity and the discharge was enough (and more than that) to operate the turbines and achieve a strong enough flow of water (figure 25) through the large pipe to transport the fish. The dimensions of the low tank were large enough as not to cause too much turbulence. The baffles in both tanks functioned properly, straightening out the flow. The collection net did not fit completely but on site adjustments could be made. The frame kept the net in position so it was not moving back and forth possibly damaging the fish. The permeability of the net was enough to accommodate the maximum discharge used. As there were several gaps at the bottom of the baffles the collection net was necessary. In future use, these gaps could be closed and a collection net would no longer be necessary as it was just as easy to enter the drained tank and use small hand held dip nets to collect the fish.
