## Fundamental Infrastructure in Reimerswaal

[Measuring erosion resistance and bearing capacity of the rail trajectory between Bergen op Zoom – Kapelle Biezelingen]

### Final Thesis Report

*Report type: Final thesis report*

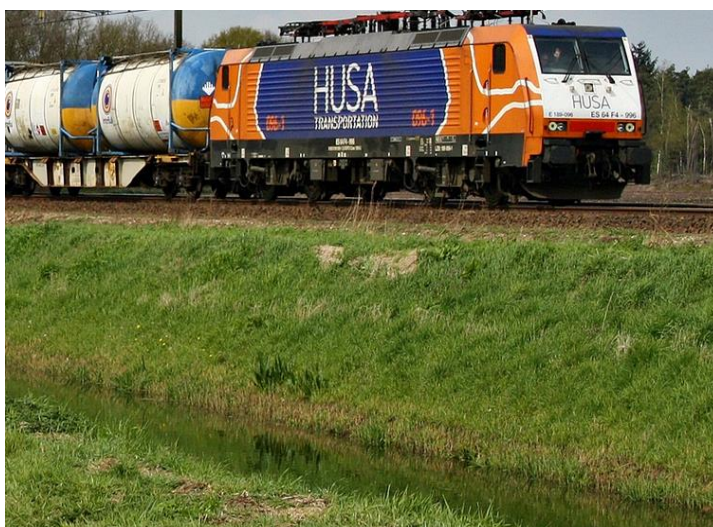
Figure 3 Railway structure (Rooijackers, 2012)

Moreover, during flood period (1/10,000 years' storm) roads and railway are not accessible due to the rise of water level which covers the railway trajectory. Therefore, the railway structure constructed at a higher ground level as shown in figure 3. An example of railway structures specifications of the existing situation can be seen in figure 4. Various sources describe that the security of the track foundation and the permanent way are crucial to keeping the railway track in operation during a flood event. Therefore, this research will consider the railway structure as a dike, to test its stability and erosion resistance.

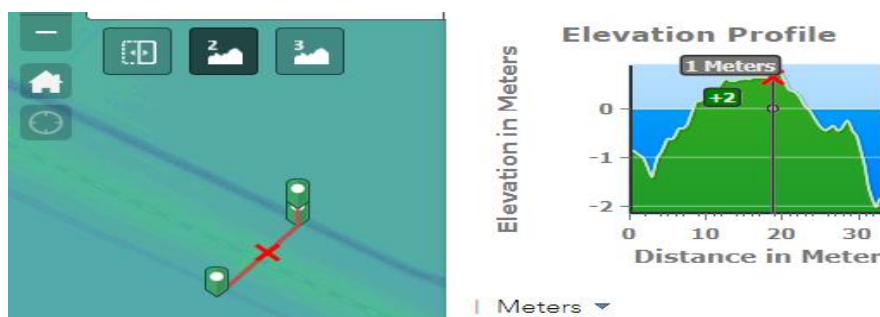
The Actual height file Netherlands (AHN), has an accurate elevation of the Netherlands. The height and cross-section elevations of areas in the Netherlands is known by using this source. In additions, the AHN is used by water board and Rijkswateraat to address the flood defenses. Figure 7 shows an example of an elevation cross-section (AHN, 2018).

Figure 7 AHN elevation (AHN, 2018)

From figure 7 the flowing can determine:

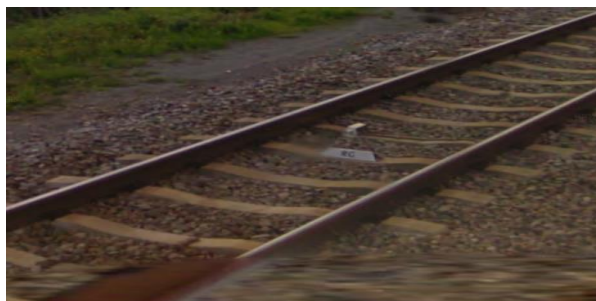
There are different types of sleepers, for example, reinforced concrete sleepers and a limit extent steel sleeper. Figure 13 shows the real sleepers in existing railway structure in Reimerswaal.

Figure 13 Sleepers in existing railway structure (google maps, 2018)

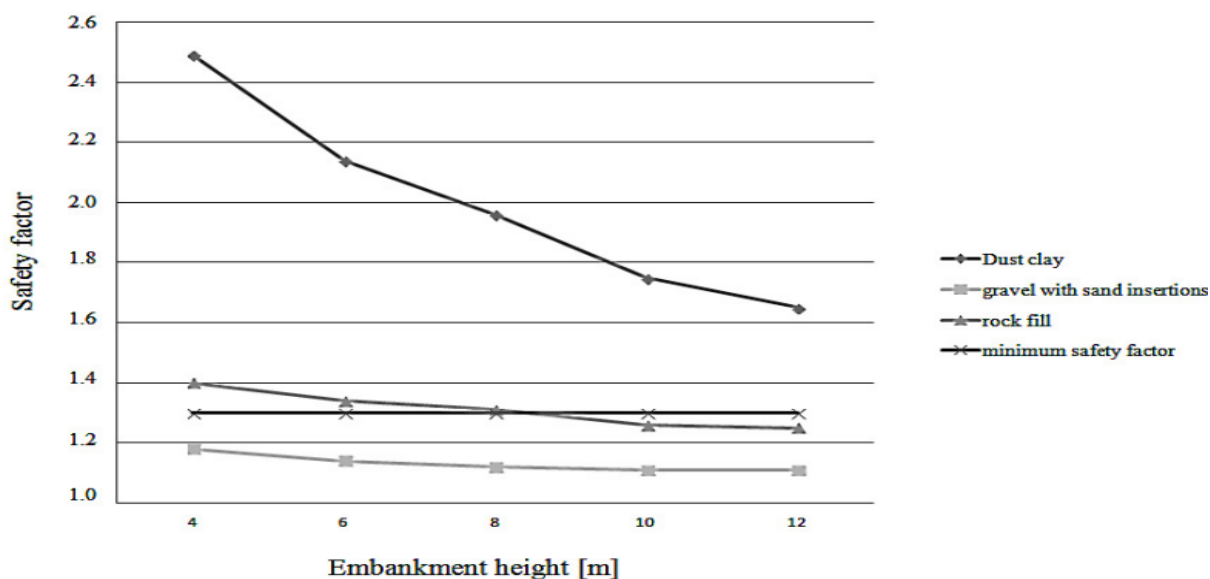
The results show that for railway embankments up to 12m stability is satisfied with cohesive soil (dust clay). For rock fill soil type the loss of stability was noticed for height from 10 to 12 m (see figure 15). Moreover, for all height studies of gravel and sand, the results show the instability of embankments (Ciotlaus, 2017).

Figure 15 Safety factor for different embankments heights and soil types (Ciotlaus, 2017)

From this study (Ciotlaus, 2017) it is clear that soil embankments have different stability with changing the soil type. For that, during this study the embankments soil properties and layers height influence the overall bearing capacity of railway foundation.

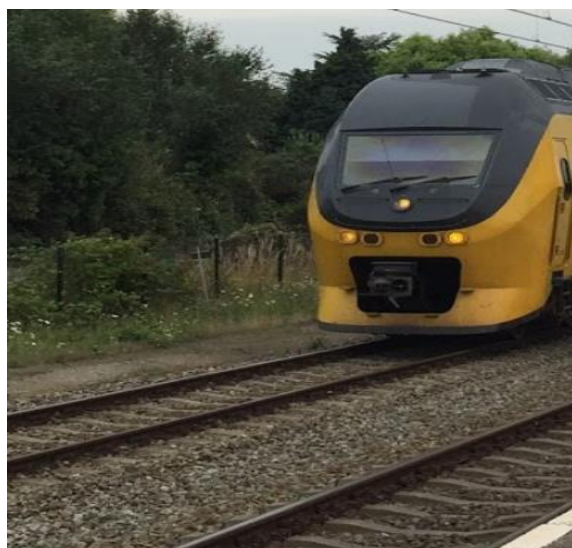
In the upper part of the railway foundation, the ballast is used for stability and drainage reasons. Figure 16 shows the existing railway foundations ballast layer used in Rilland-Bath railway station. In this research, the properties of the ballast used in Reimerswaal railway foundation need to be specified. For that, 'Survey of Railway Ballast Selection and Aspects of Modelling Technique' (Alemu, 2011) is used in order to understand the primary function of using ballast in railway foundation. This study described the ballast as the primary layer in railway where sleepers are laid. The primary function for ballast is to transfer the loads from the superstructure to the subgrade without causing failure.

Figure 16 Ballast layer used in Rilland-Bath railway station (Kraai, 2017)

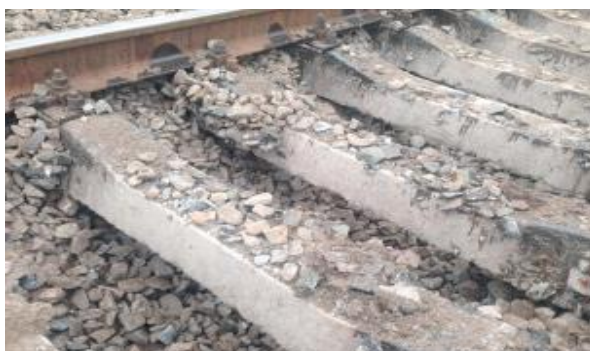
**Settlement:** the settlement failure can be divided into two parts: settlement of embankments and settlements of ballast (See figure 20). The settlement of embankment is happening when there is an increase in vertical strain stress. The cause of ballast settlement is ballast fouling. The settlement of ballast frequently depends on the quality such as (mechanical, physical, shape and strength of the ballast structure) and the underlying structure (Alemu, 2011).

Figure 18 Settlement (Kruglikov, 2018)

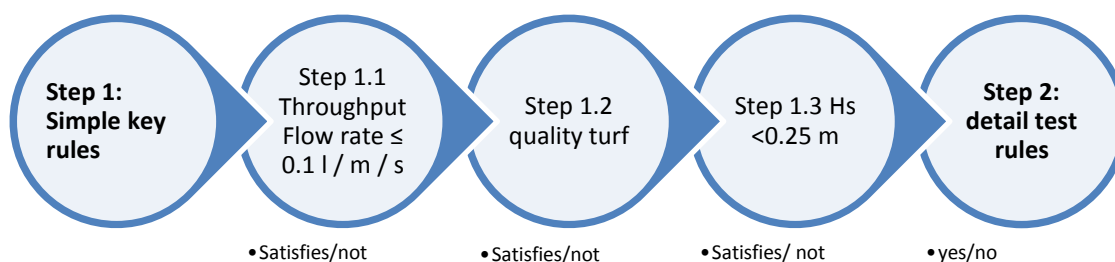
Then, the grass revetments analyzed by using the "guidance keys grass coatings dikes serving to draft the manager judgment (B0)" (More, 2012). In this report, the behavior of coatings on grass has studied. From this guide, the assessment carried to check the grass revetments. The assessment carried by using the following steps:

Figure 21 Steps to check erosion of grass revetments

From these steps, the erosions of grass revetments will be checked. These steps mentioned in the method section (See appendix 1 for the Dutch scheme).

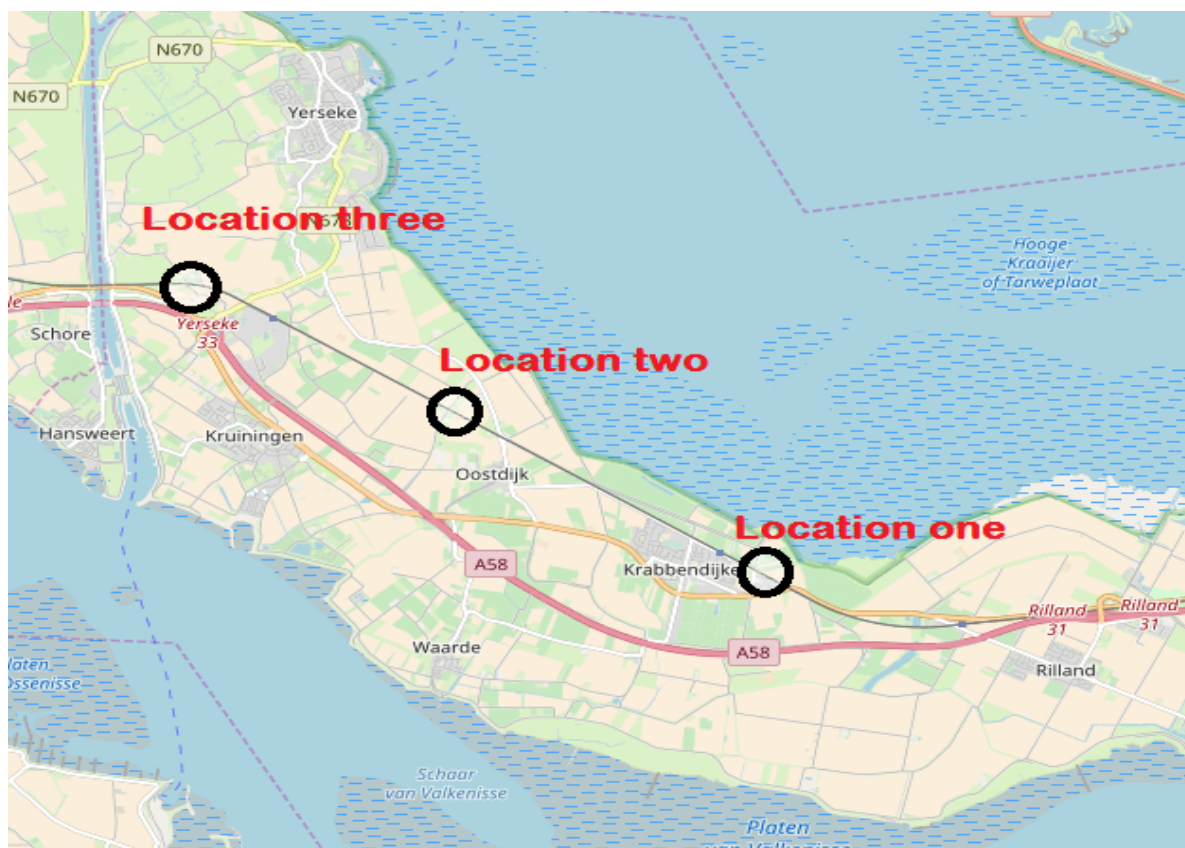
Figure 22 Research locations (openstreetmap, 2018)

In the start of this research, it was essential to determine three research locations to analyze the railway trajectory. Three locations were identified with a high, a low and an average height. The research location specified by using (AHN) the height map of the area. Figure 23 shows the three locations used in this research. These locations coordination (x, y) are:

- Average elevation area: location 1: 67258.47072, 383084.0487
- Low elevation area: location 2: 63552.85868, 385538.3253
- High elevation area: location 3: 60049.76304, 387639.1533

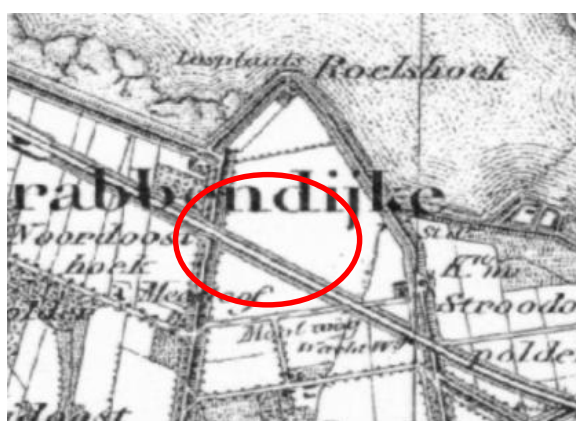
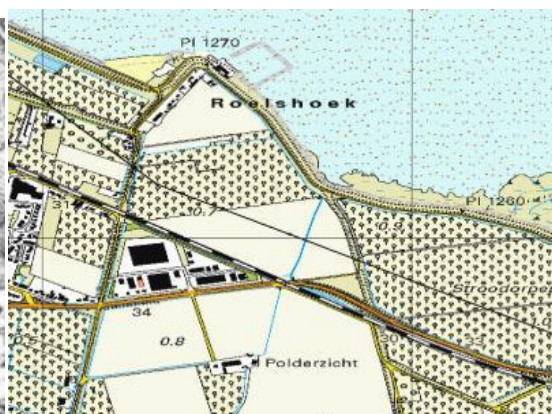
For each location, the comparison was made between 1852 and 2017 to check the embankments soil type. For location one as shown in the figures 30 and 31 below the embankments has the same soil that removed from the ditch. Also, there is no difference between the map of 1852 and 2017, so the embankment soil type is clay.

Figure 33 Location 1 1852 (topotijdreis , 2018)

Figure 34 location 1 2017 (topotijdreis , 2018)

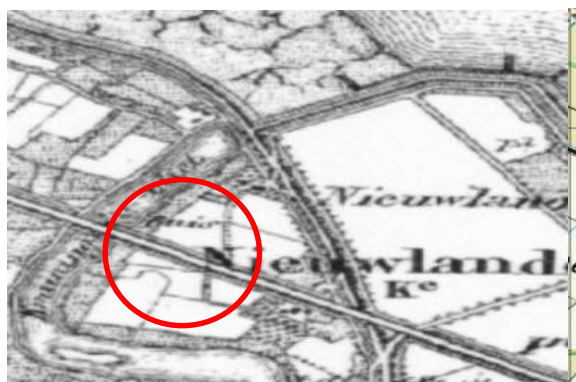
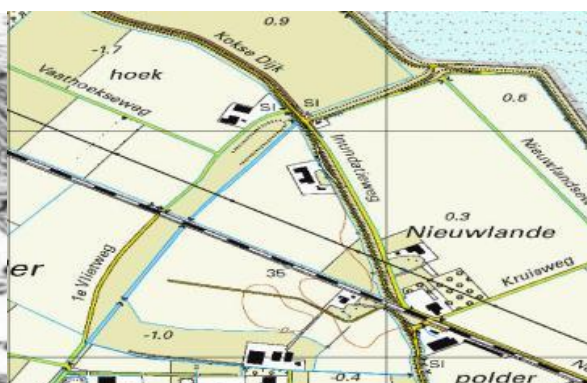
The second location has also checked, the figures 32 and 33 below show the compression of the railway line between 1852 and 2017. Figure 32 shows the railway trajectory embankments in 1852 where it built of clay. In addition, figure 33 shows the railway embankments in 2017 which almost the same area and bath as in 1852 (figure 32). From both figures, the railway trajectory embankment is still the same which is clay.

Figure 36 Location 2 1852 (topotijdreis , 2018)

Figure 35 Location 2 2017 (topotijdreis , 2018)

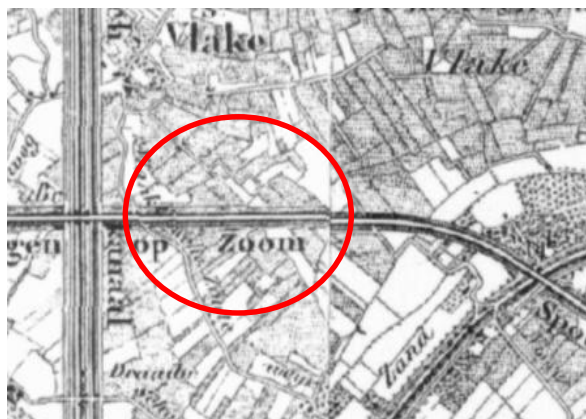
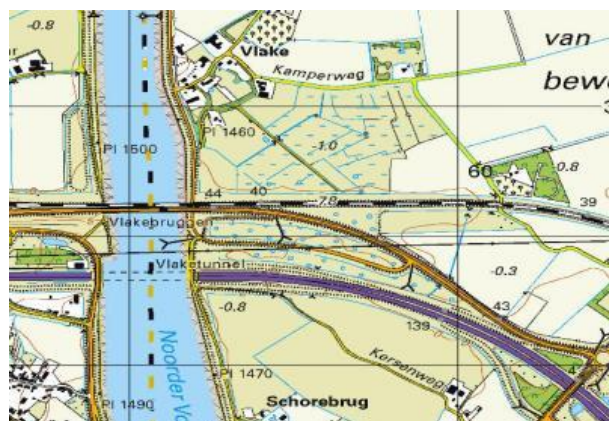
In location three the compression was challenging to organize due to various embankments presences on this location. In figure 34 and 35 are the railway trajectory in 1852 and 2017, respectively. There are few changes done on the railway trajectory embankment. For that, the soil type has changed from clay to sand in the new design. Also, the ProRail experts have confirmed that location three new embankments of sand.

Figure 37 Location 3 1852 (topotijdreis , 2018)

Figure 38 Location 3 2017 (topotijdreis , 2018)

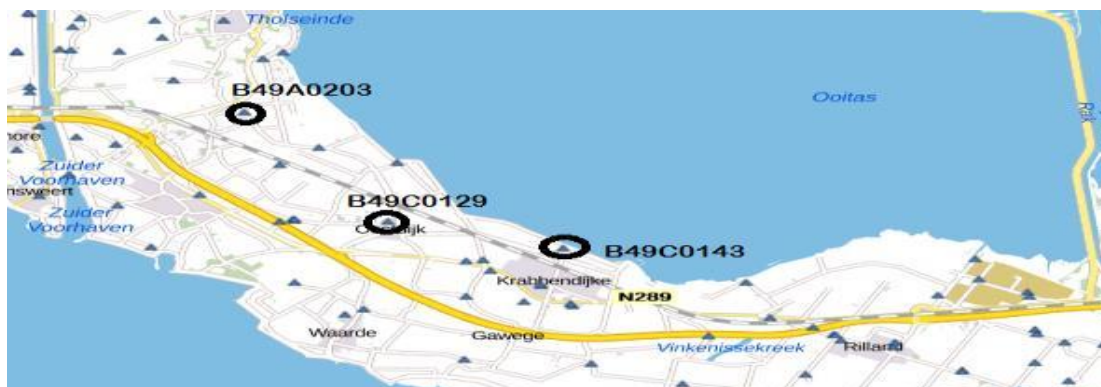
Figure 39 Points used to check groundwater level (dinoloket, 2018)

The groundwater level determined by using the website dinoloket. The groundwater level is an essential factor for the D-Geo stability model and checks. The groundwater level has identified for each cross section. The figure 39 shows the three points had been selected to check the groundwater level of each location.

By using the dinoloket, the groundwater level has been determined for each location. Table 6 shows the groundwater level for all the three locations. This groundwater levels will be used for D-Geo stability checks and settlements calculations.

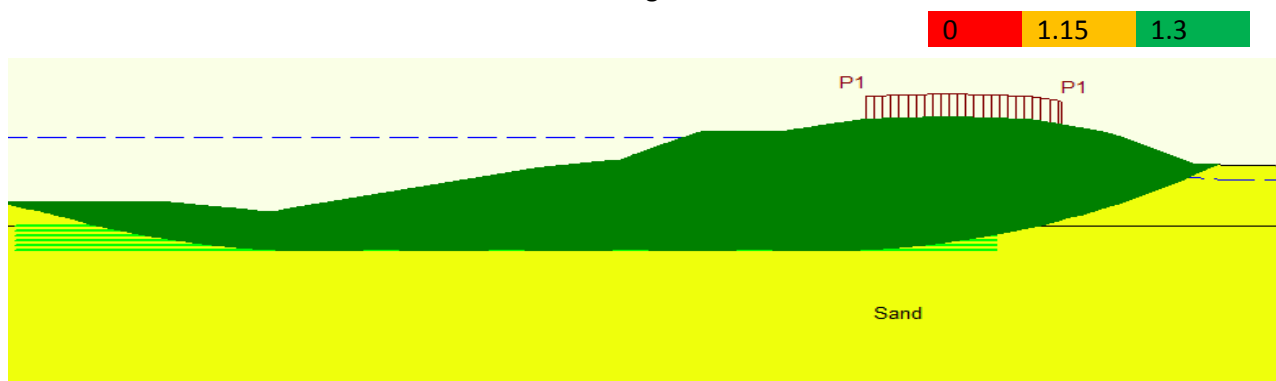
Figure 50 Slope stability overview of location three left

From the table above, all scenarios have a safety factor higher than 1.3. The safety factor decreased during the flood, but it is still higher than the minimum safety factor (see figure below). For that, the dike on the cross-section three is safe to use during and after the flood.

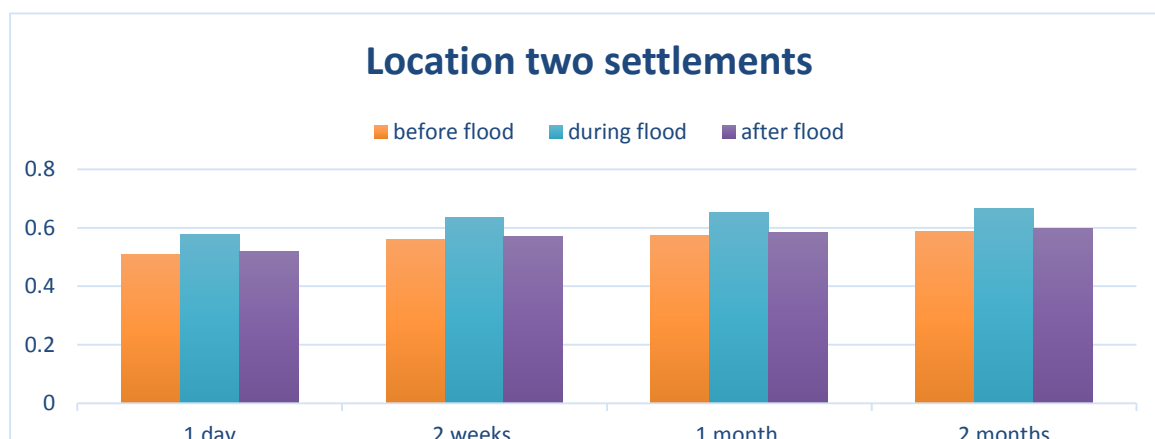
Figure 53 Location 2 settlement results

Figure 53 shows the settlements results for cross-section two before, during and after the flood. In all time periods, the settlement values before and after the flood were almost the same. However, the settlement values increased during the flood.

For location two the results founded are shown in the table below. The settlement is still high due to soil type (clay). The settlement difference during and before the flood is almost 8cm. While the settlements difference after and before the flood is virtually is 0.01 in all time periods (For detail calculations check appendix 6).

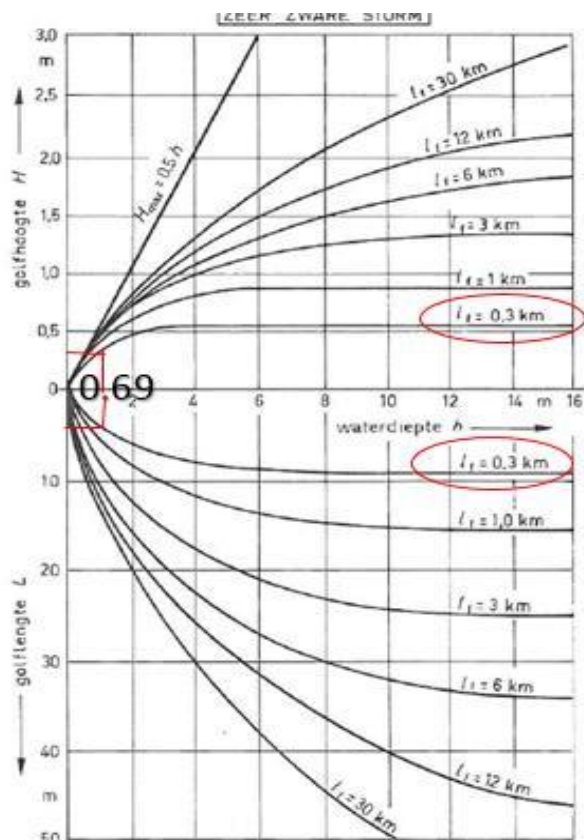
Figure 57 Location 2

The water depth and effective fetch used to determine the wavelength and wave height. The wavelength and height specified by using the following graph.

From both figures above, the wavelength and height have specified. The following table 17 shows the results for each location.

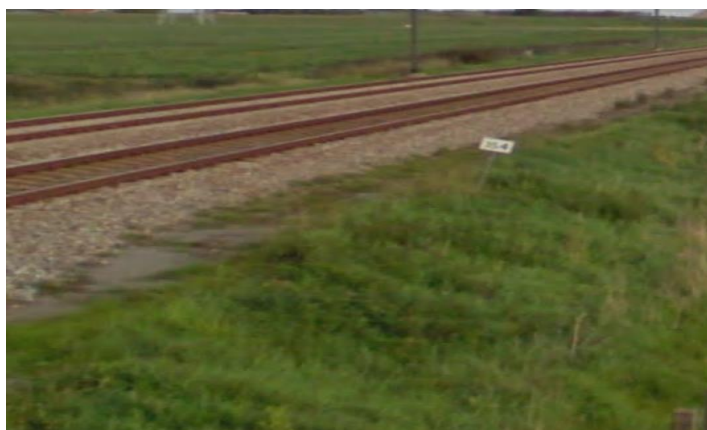
Figure 58 Grass revetment on location 2 (Googlemaps, 2018)

*Explanation:* The vegetation along the railway trajectory was built in the 80's. The grass has had plenty of time maintenance developments. In location one and two the grass revetment is the same size, and there is no presence of big trees (see figure 58).

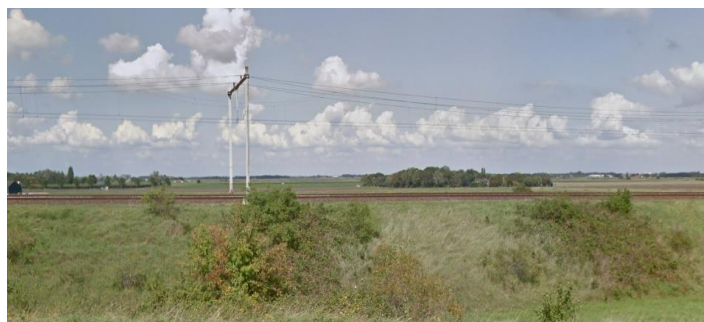
Figure 59 Grass and trees on location 3 slope (googlemaps, 2018)

However, nowadays the slope of location three has different grass and trees with different sizes (see figure 59). It clear that the maintenance has not been done for a while. Due to the presence of big trees with low-density grass, the quality of the revetments is not sufficient.

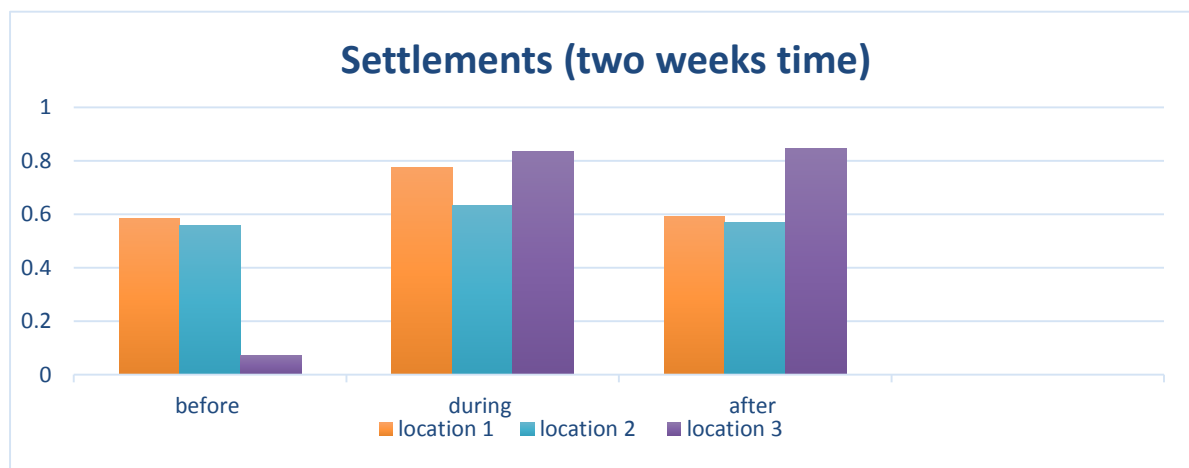
Figure 60 Compare the settlement between location one, two and three in two time periods

The figure below made to compare the settlement between the three cross-sections with the period of two weeks. From figure for location one and two, settlements changes due to the presence of water were small. In location three, settlements changes due to the presence of water are too high, and this expected due to sandy soil type.
