Report
Ecological Research Elastocoast
Dutch Pilot Locations Petten and the Zuidbout

Location Petten (Noord-Holland), 25-04-2009

Location the Zuidbout (Zeeland), 26-04-2009

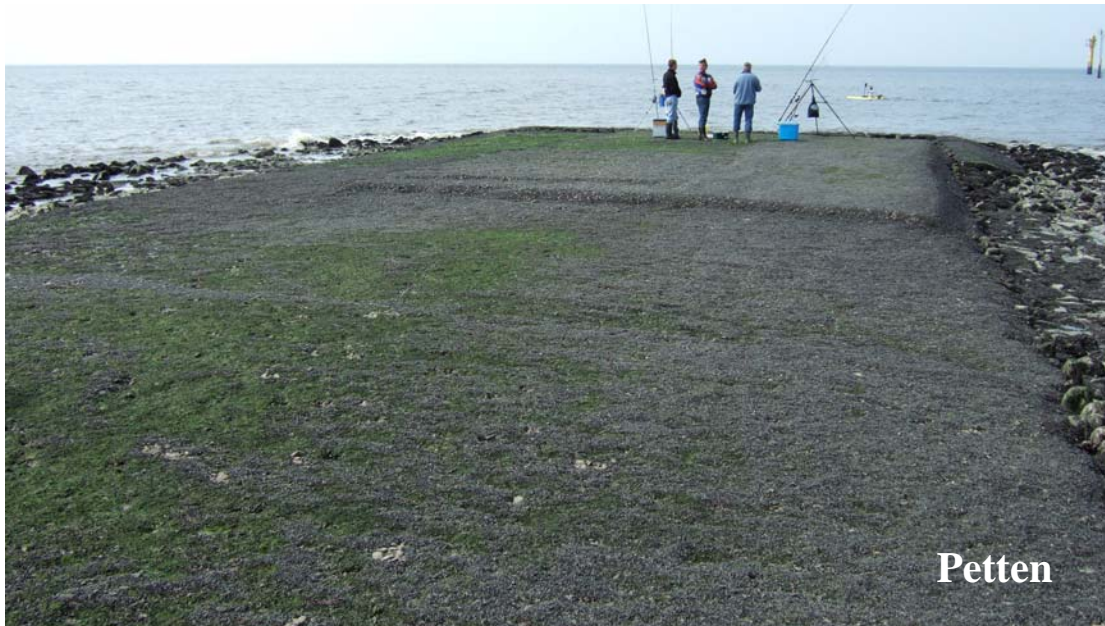
On april 25th, 2009 the dike was mainly covered with mussels (*Mytilus edilus*), which formed a dense layer on Elastocoast. Some areas however, were not covered with mussels and formed a distinct gap in which the Elastocoast layer was clearly visible. Taking the density of the mussels in consideration it is quite likely that mussels were also present here, but have disappeared because of some kind of disturbance. Erosion of the polyurethane was also visible here.

Also patches of *Blidingia minima* were present, and few places were covered with *Fucus Spiralis*. Purple laver was no longer present. Algal coverage was still quite zoned, mostly the areas directed towards the sun were covered. Another animals which has occupied the Elastocoast is the barnacle. Numerous of these animals were seen on the parts of the layer not covered with mussels and between algae.

The pores of the material were still filled with sand and parts of shells. Isopods were found in the pores, burrowing in the sand. It is likely more organisms have occupied the pores.

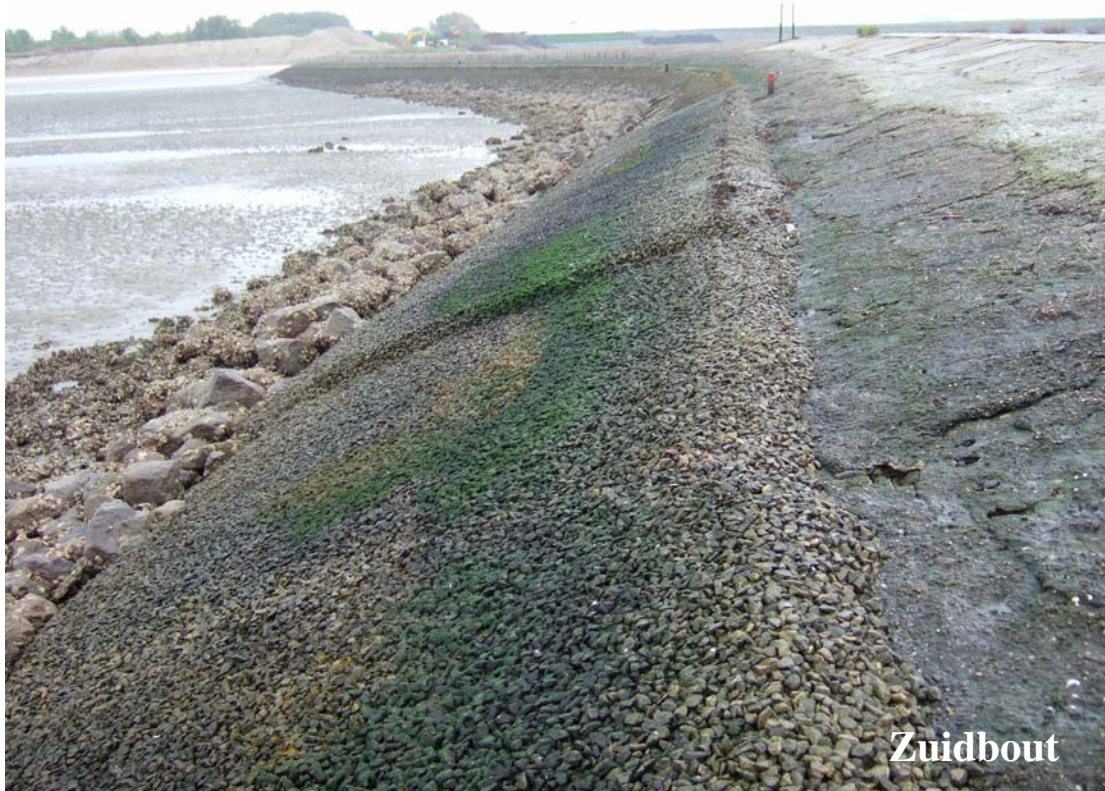
On April 26th, 2009 there still was a strong vertical and horizontal zonation on the part of the dike which has been refurbished with Elastocoast. Seen from the top, the vertical zonation is marked by *Blidingia minima* and *Fucus spiralis*, which forms a very sharp boundary with the zone below (which is occupied by many snails and barnacles).

Horizontally, there are areas which show the vertical zonation, and areas which hardly have any vegetation at all (although snails and barnacles are found all over the lower part of the Elastocoast layer). Especially on the most southern part of the dike vegetation has recovered. On this part of the dike the slope is less steep than the slope further towards land. Steeper slopes can result in higher (wave) dynamics, which in turn can result in less favourable circumstances for algal attachment. This is probably seen on the northern areas (more towards the land) of the dike. The effect of dynamics is perhaps also seen on areas where the Elastocoast layer changes in thickness. It is possible that waves are being 'bounced back', creating more difficult circumstances for algae to attach on the layer.

Also differences in substrate may be a cause for horizontal zonation. On areas where a lot of sand has been distributed and where Vilvoordse rock was placed on top of the Elastocoast layer show a better recovery of vegetation. This makes the surface of Elastocoast less smooth, creating better circumstances for algae to attach.
